2022 LAKE WHITEFISH SPAWNING AND HABITAT INVESTIGATIONS IN THE VICINITY OF THE MATABITCHUAN GS, MATABITCHUAN RIVER

Ontario Power Generation Inc.
700 University Avenue
Toronto, Ontario, M5G 1X6

January 2023

C. PORTT and ASSOCIATES
56 Waterloo Avenue
Guelph, Ontario, N1H 3H5
cportt@sentex.net

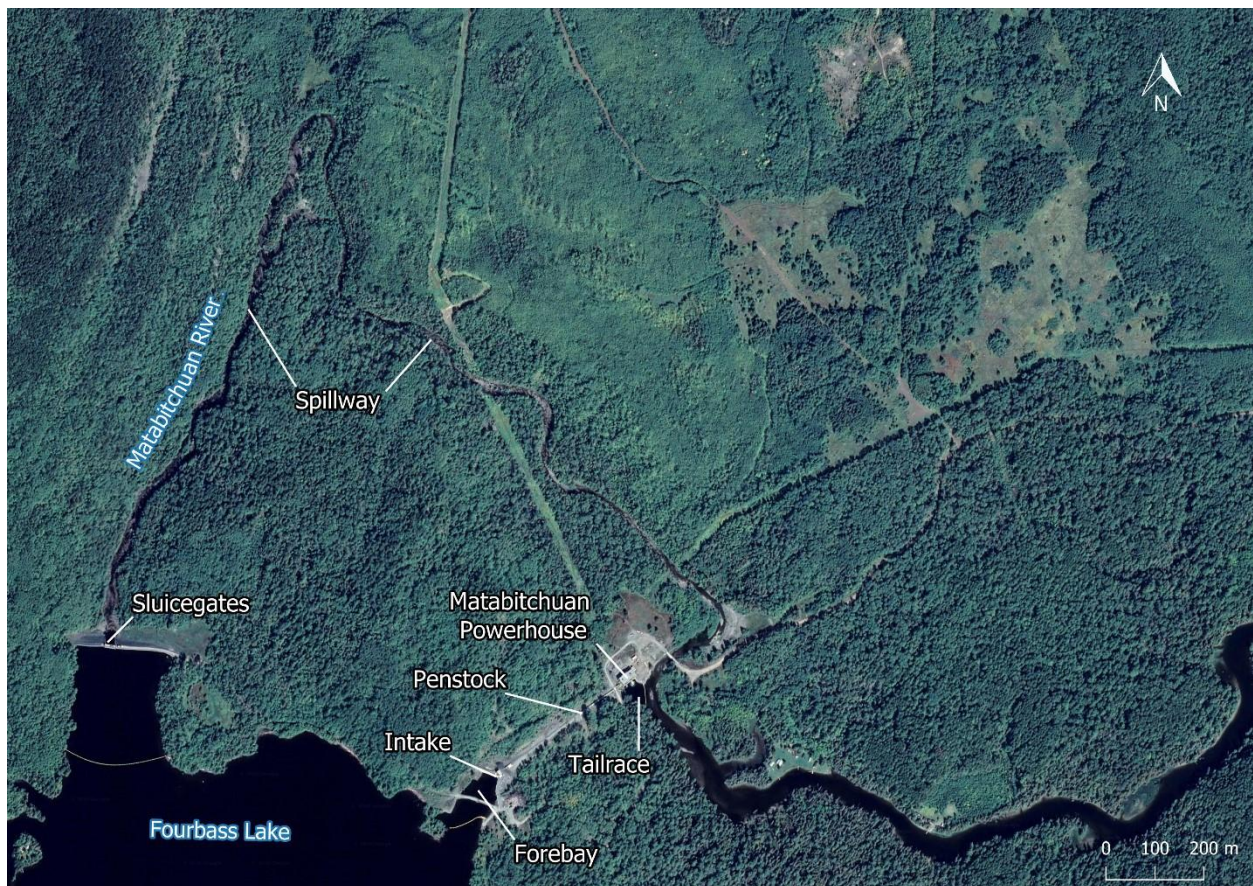
Figure 2-1. Matabitchuan River in the vicinity of the Matabitchuan GS.

Figure 2-1 identifies project infrastructure and illustrates the general habitat and flow conditions in the vicinity of the GS. The Matabitchuan GS control dam (sluiceways) and intake structure are located on Fourbass Lake, approximately 800 m apart. The control dam and intake structure divert water to the powerhouse through penstocks, bypassing approximately 3 km of the Matabitchuan River that is now the spillway. Downstream from the GS the Matabitchuan River winds 3.6 km east to Lake Timiskaming (Figure 1-1; Figure 2-1). The low gradient of the river downstream of the GS means that the GS tailrace and the lower portion of the spill channel are readily accessible to Lake Whitefish from Lake Timiskaming.

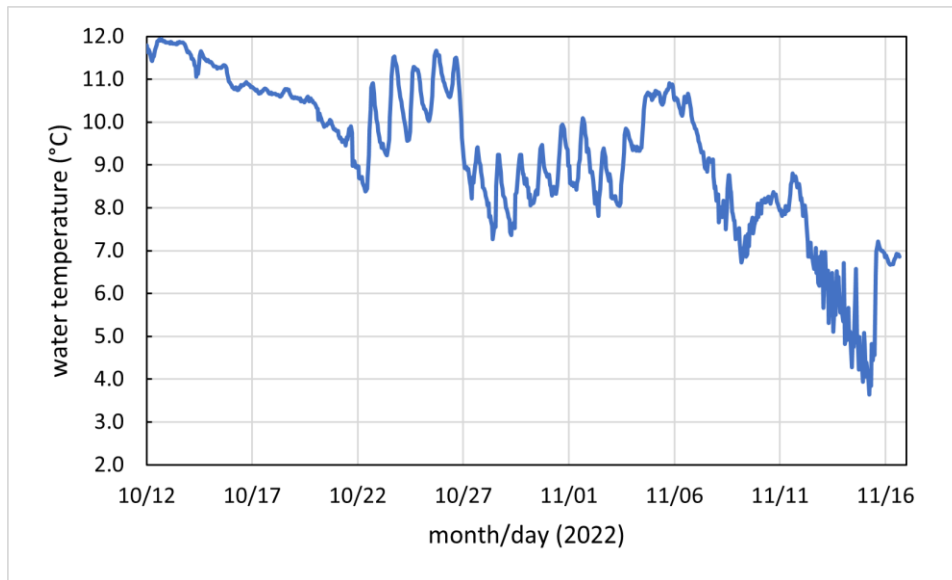
Figure 3-1. Logged water temperature in the Matabitchuan River, adjacent to the GS tailrace for the period October 12 – November 16, 2022.

The logged water temperature decreased slowly in the autumn of 2022 (Figure 3-1), falling below 7.8°C for the first time on November 8. From November 8 through November 13 the water temperature averaged 7.5°C and fluctuated between 5.1 and 8.8°C. During the spawning investigations (November 14-16) the water temperature averaged 5.7°C and fluctuated between 3.6 and 7.2°C.

While typical diurnal temperature fluctuations occurred during parts of the monitoring period, smaller, short-term fluctuations occurred at other times (Figure 3-1). The smaller fluctuations in water temperature were apparently due to the location of the temperature logger, which was situated at the confluence of the tailrace flow and the spill channel flow (Figure 3-2). The water from the tailrace and the spillway could be quite different temperatures depending on the flow in the spillway (Table 3-1). On the first day of the field investigation (November 14) the temperature of the tailrace water, which comes directly from the headpond to the GS via the penstock and is then discharged to the tailrace, was measured at 7.6°C, while the temperature of the spillway water, which comes from the headpond control dam via approximately 3 km of spill channel, was measured at 3.0°C. On November 15 the tailrace flow was 7.2°C and the spill channel flow was 6.7°C, and on November 16 the tailrace flow was 6.7°C and the spillway flow was 6.3°C. On November 14 the spill channel flow was very low (<1 m³/s) and contributed a very small proportion of the combined riverflow downstream of the GS, while on November 15 and 16 the spillway contributed approximately 24% of the combined riverflow downstream of the GS (Table 3-1).

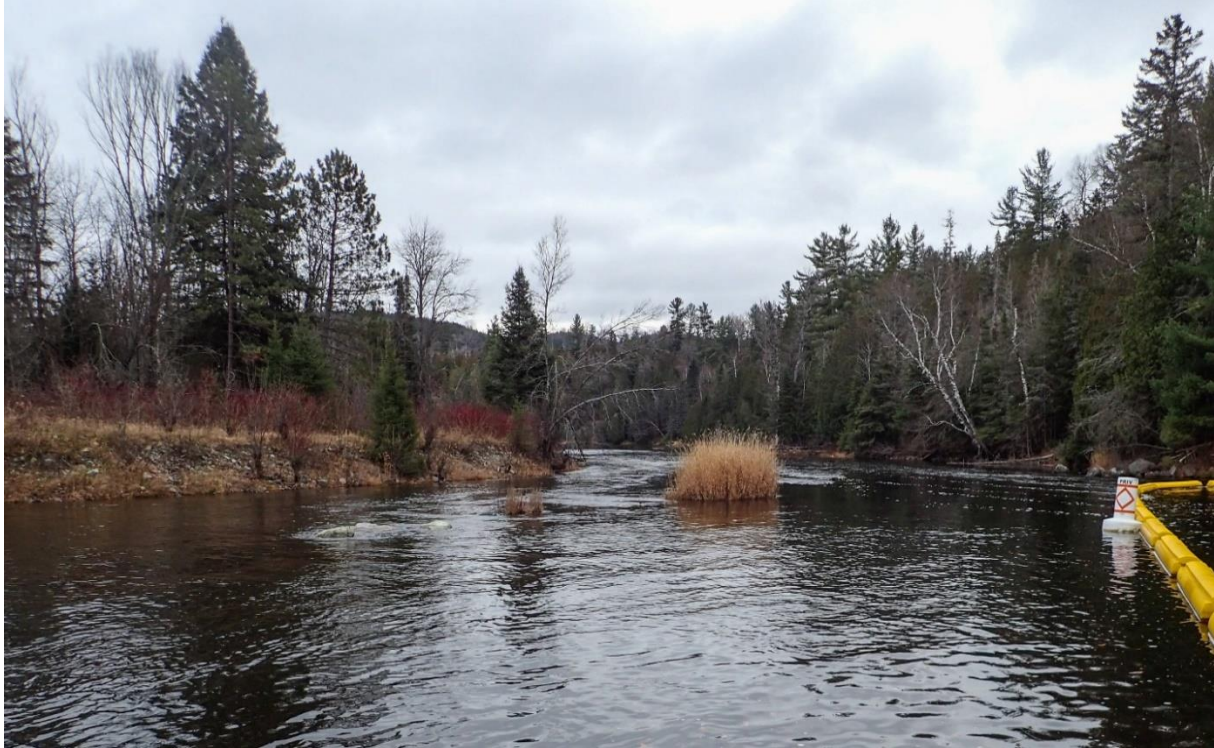
Figure 3-3. View downstream showing the Lake Whitefish spawning area. The tailrace is on the right, and the shallow shoal is indicated by the patches of emergent vegetation and a few exposed rocks in the centre of the channel. November 15, 2022.

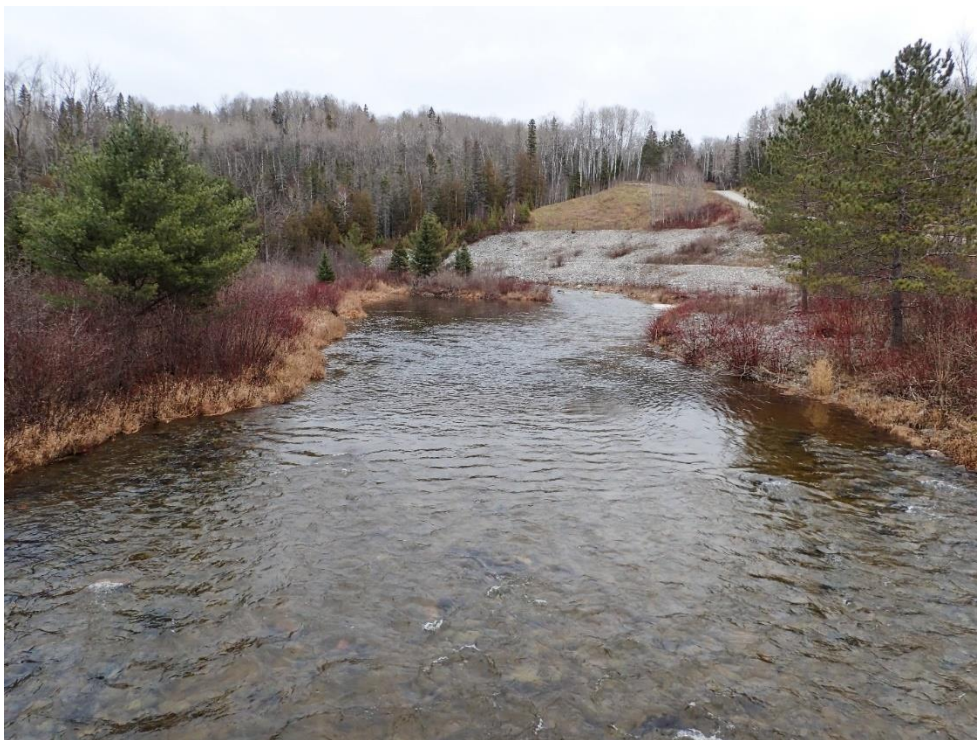
Figure 3-4. View upstream from the road bridge, showing the lower gradient portion of the spillway. November 15, 2022.

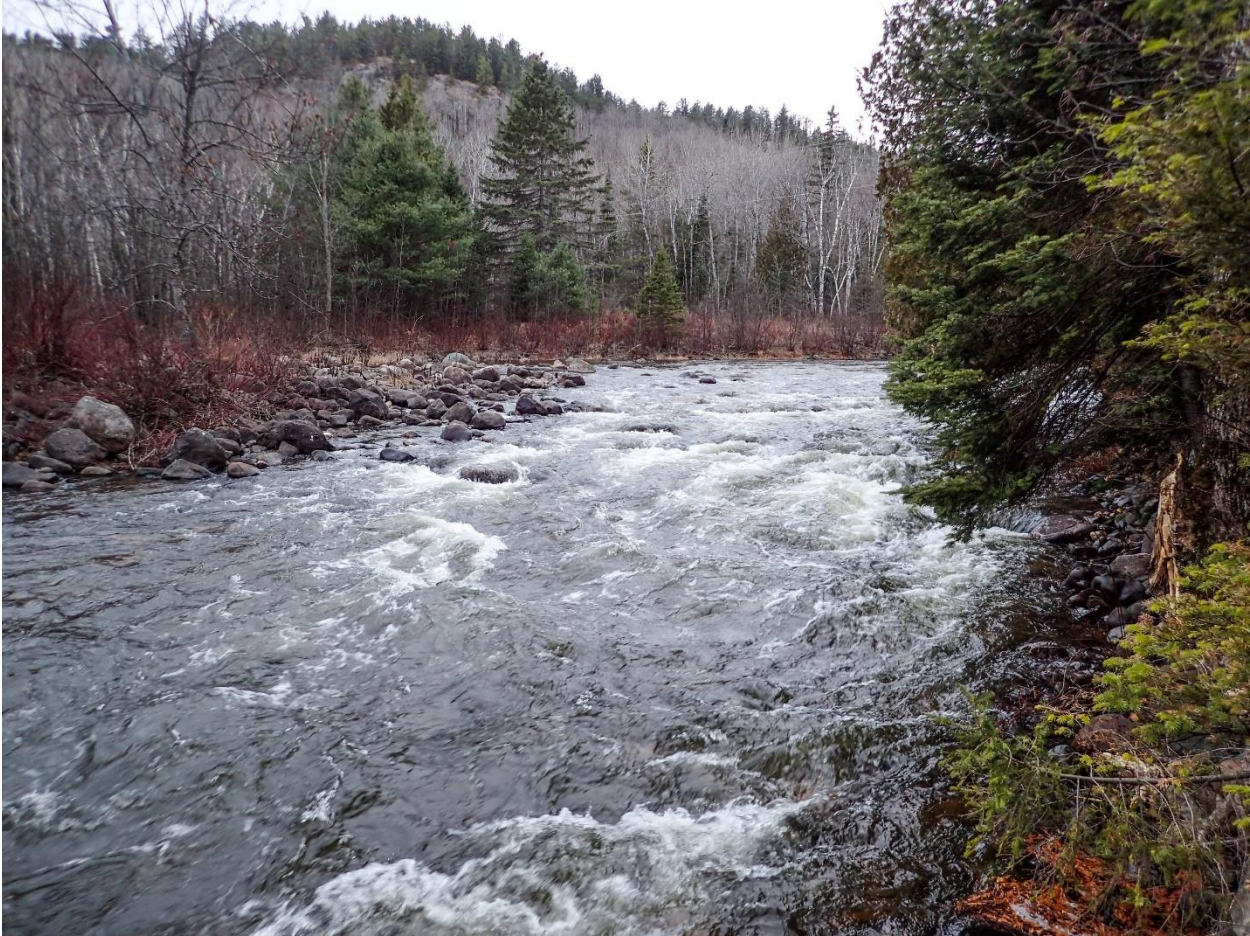
Figure 3-5. View of the spillway, looking upstream from the farthest upstream location examined for spawning Lake Whitefish. November 15, 2022.
