**Heritage Impact Assessment  
Coniston GS Life Extension Project Project,  
Wanapetei River, City of Greater Sudbury,  
District of Sudbury, Ontario.**

CHIA Report  
November 21, 2022

Heritage Impact Assessment Report

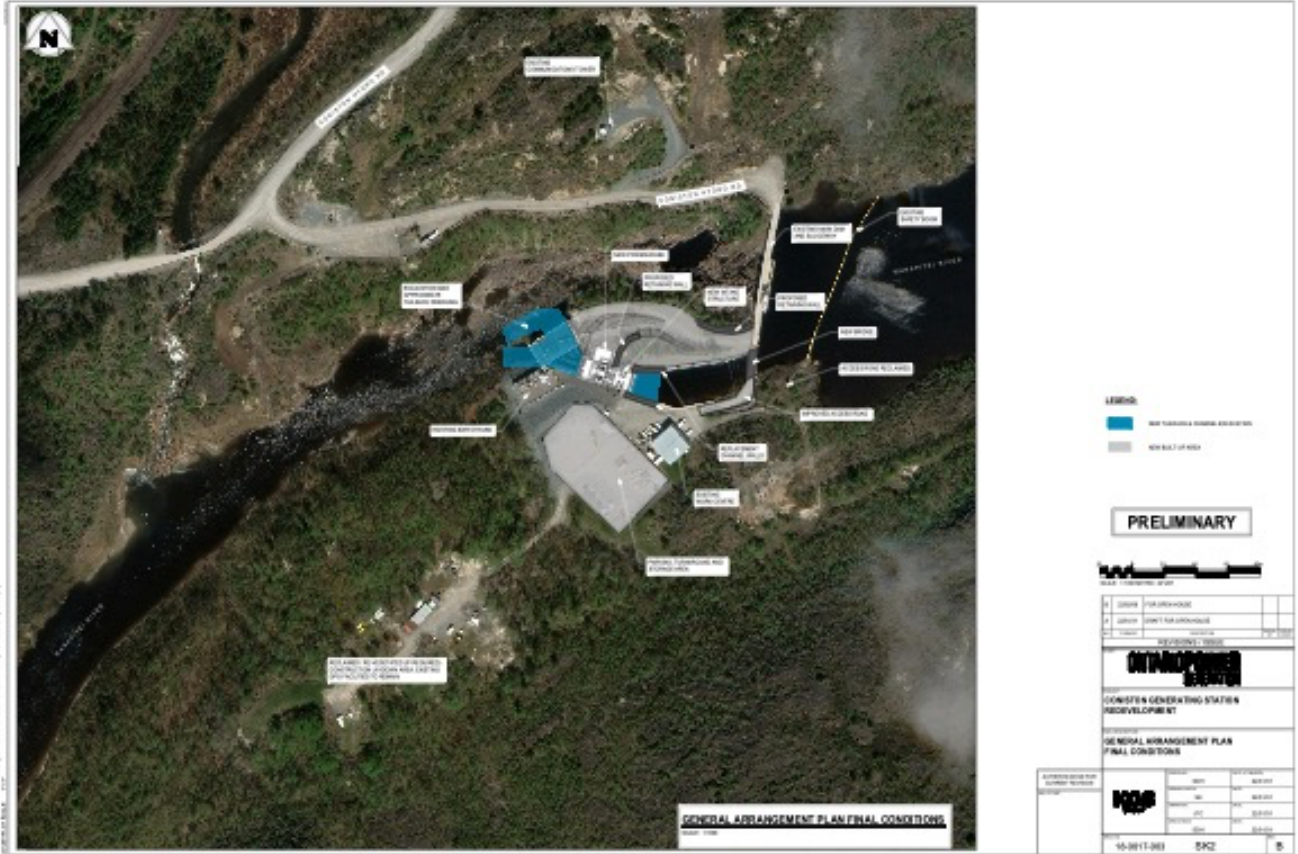
To date, a draft plan of the preferred alternative has been prepared. OPG has selected a station configuration that will have two horizontal units rated at a total of just over 6 MW. Figure 35 shows the proposed Draft Final Site Design for the Coniston GS.

Figure 35: Proposed Draft Final Site Design for the Coniston GS.

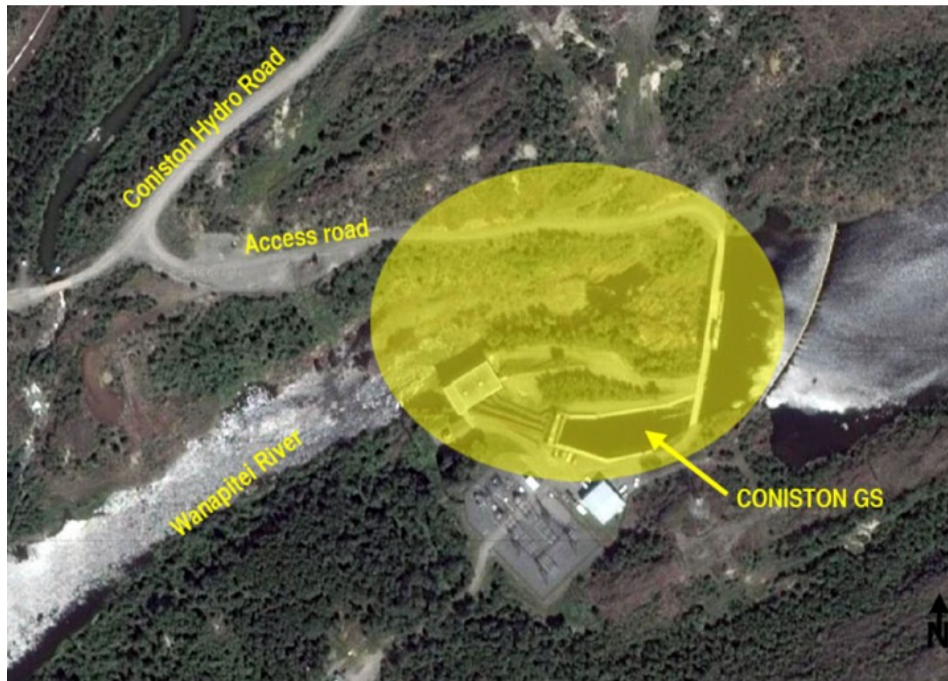
Figure 2: Coniston GS Provincial Heritage Property (PHP), reproduced from Unterman McPhail (SCHV 2017).

At the time the CHER was completed (2017), the Provincial Heritage Property comprised Coniston GS and main dam with sluiceways, inlet, forebay canal, headworks, penstocks, powerhouse, tailrace, transformer house (carpenters' shop) and access road (Figure 1). Between 2016 and the property inspection associated with this report in 2020, the transformer house (carpenters' shop) has been removed and replaced with a new fenced-in transformer pad. The maintenance shop, which is a contemporary structure, and ancillary features including the transformer station, the transmissions lines and the former operators' colony, which are not within the ownership of OPG, do not form part of the Provincial Heritage Property (Figure 2).

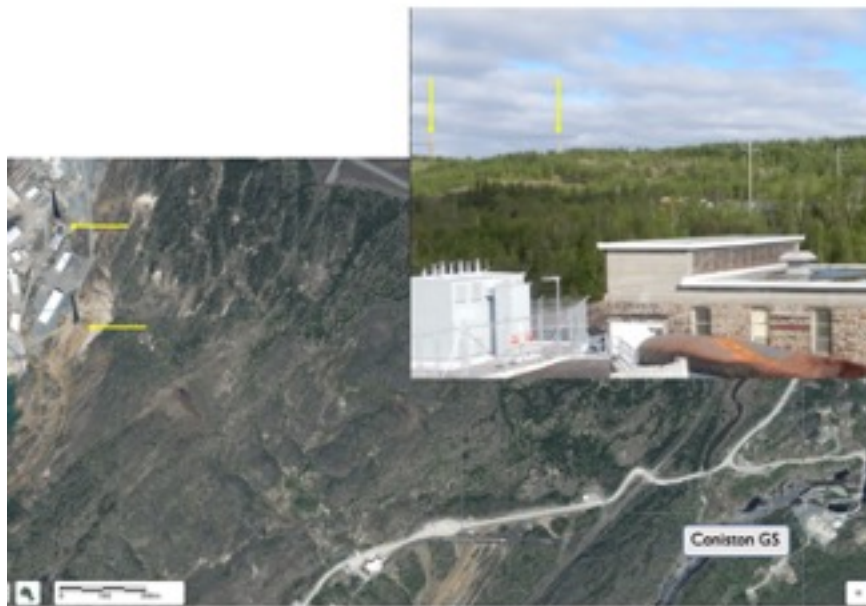
Figure 3: Aerial and oblique views showing former smelting works chimneys in distance, marked by yellow arrows.

Coniston GS is accessible from Highway 17 via Coniston Hydro Road, running south. The community of Coniston is accessed by Regional Road 93, and Coniston Hydro Road intersects Highway 17 about 2.6 kilometres east of Regional Road 93. Coniston Hydro Road continues beyond the access road to the GS to the south end of the industrial park at the former Mond Nickle Company smelter site. Mond Nickle was a major customer of Coniston GS starting in 1913. The site of the smelter, built in 1954 and 1959, remain visible from Coniston (Figure 3).

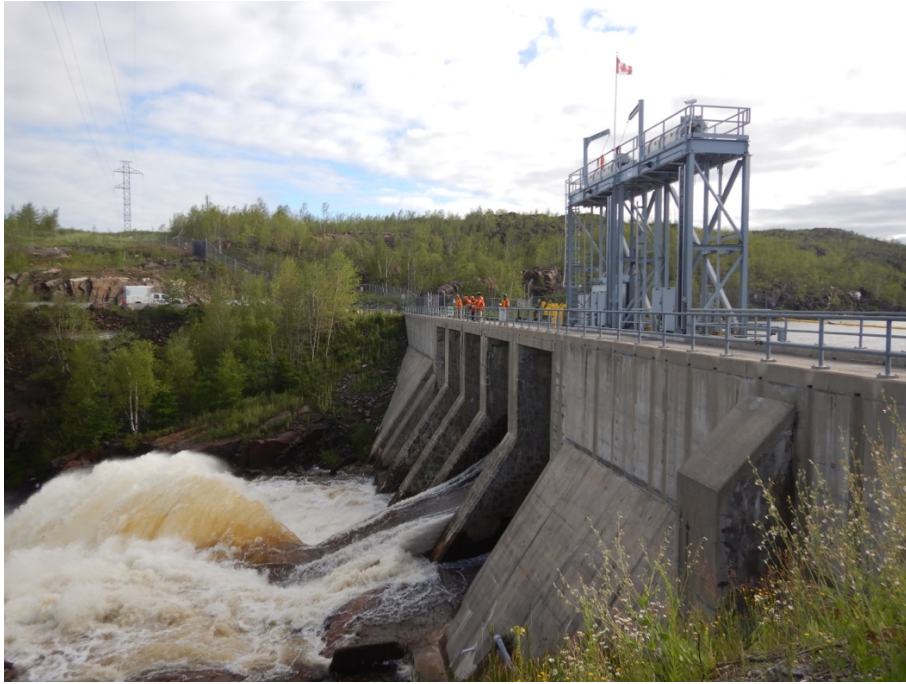
Two concrete dams control the flow of the Wanapitei River as part of Coniston GS. The main dam is a concrete structure with five sluices and left and right concrete gravity wall sections built in 1938 (Figure 4). The concrete dam replaces a log crib dam with six sluices and a log slide. The log crib dam was constructed as part of the original development of the site in 1903 and 1904. One early photograph of the headworks and penstocks may include a partial view the original dam (Figure 5). A second dam at the inlet controls flow into the forebay. This dam is concrete and also dates to the 1938 construction when the original log structure was replaced. The structures support a single traffic lane providing access to the site, and is currently reinforced with temporary metal ramps (Figure 6). The main dam is about 80 metres in length, and the forebay dam about 20 metres. At the separation point between the two dams a gravel service ramp provides access to the powerhouse (Figure 7).

Condition: good.

Figure 4: View of dam and sluiceways (2020).

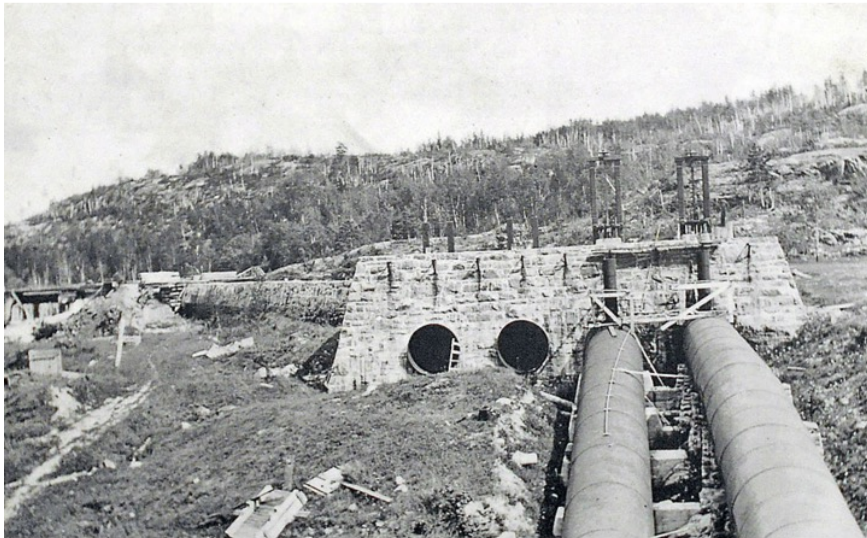
<p><b>Headworks.</b> The headworks occupy the west end of the forebay canal and date to the original 1904 construction (Figure 5). Stone masonry walls are visible on the north and south sides, while the west face has been encased in concrete since construction (Figure 10). As designed, the headworks include outlets for four penstocks. Two penstocks were coupled in 1915 to provide an increased volume of water to Unit 3. Each gate is operated by a single hydraulic hoist (Figure 11). The hoists replaced the original manual hoists and timber gates at an</p>	<p>July 2020, A. Hinshelwood examined the property on foot accessing the structure from the north and south sides and the access gantry.</p> <p>Figures 10 – 11.</p>	good

Figure 5: Headworks and penstocks 1 and 2 under construction. Dam visible to left of photo. Source, OPG. Reproduced from Unterman McPhail (SCRR 2017).

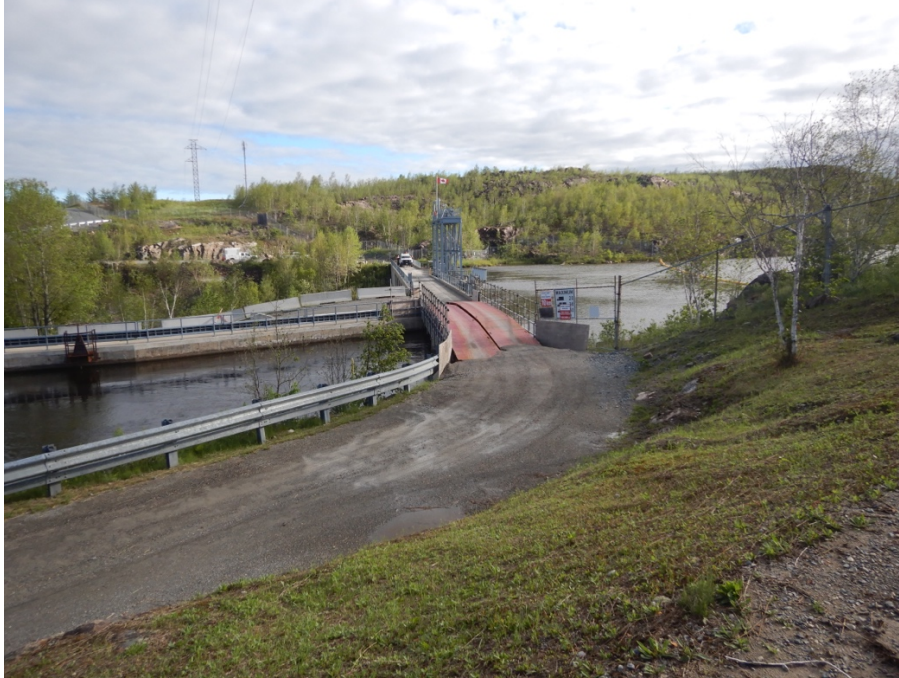
Figure 6: Access road crossing the dam and entrance to forebay canal. Note metal vehicle ramps.

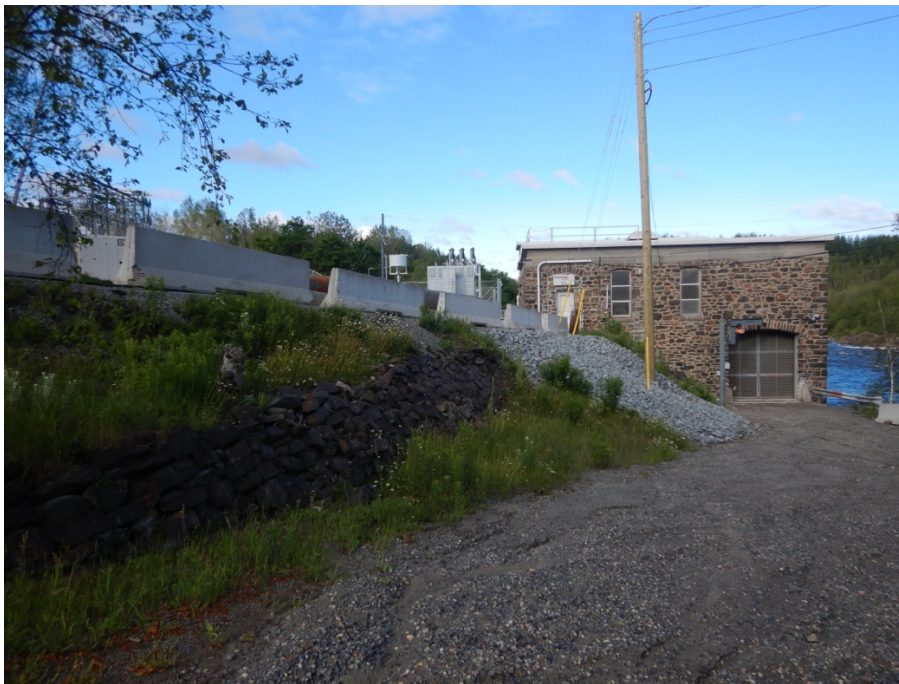
Figure 7: Service road running from between the two dam structures and the east entry to powerhouse.

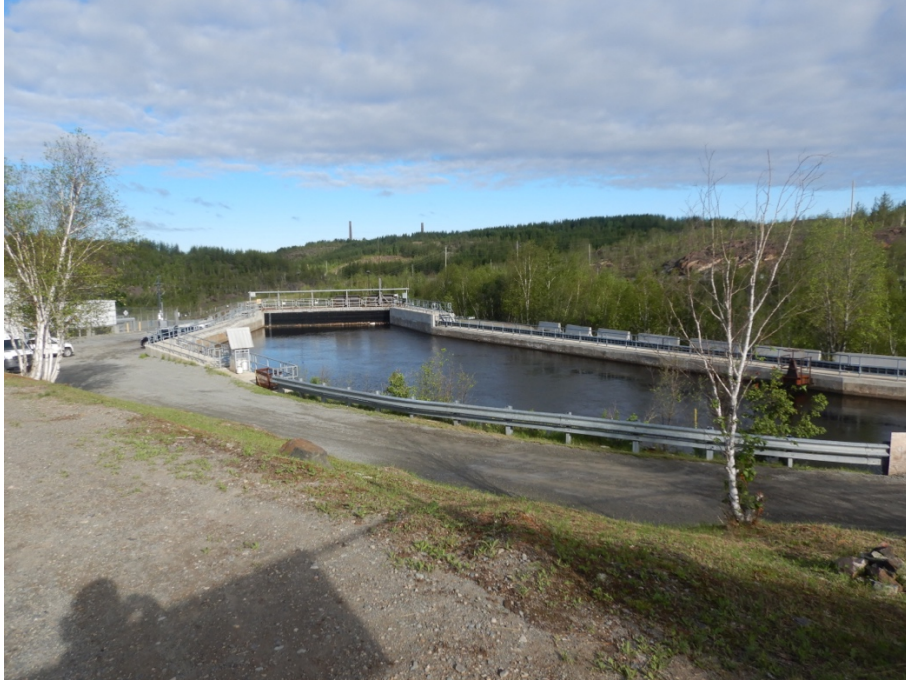
Figure 8: Forebay canal with headworks in distance. Note smelter chimneys on horizon.

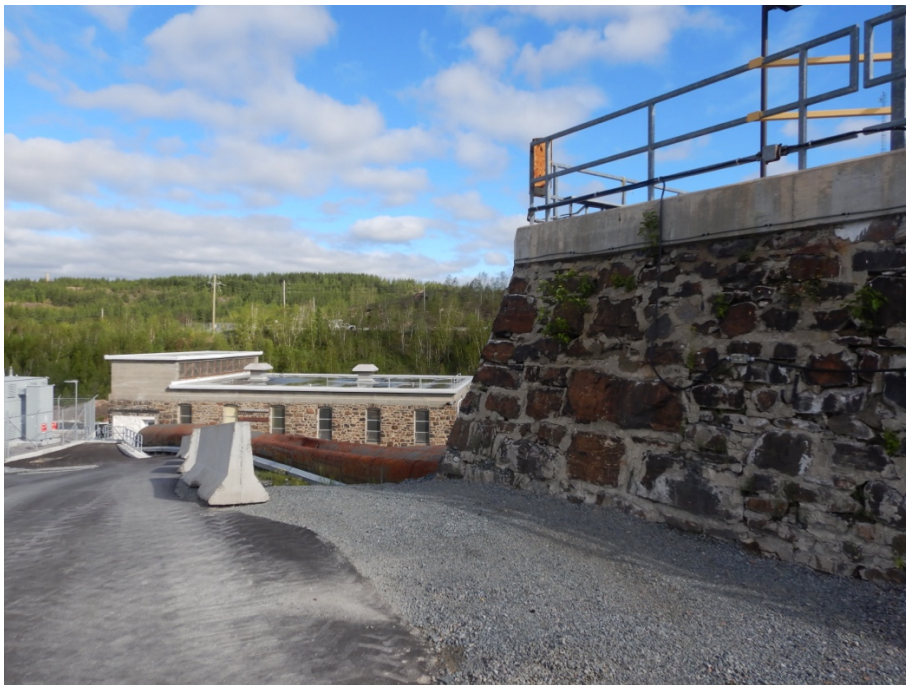
Figure 9: Downstream end of forebay canal at headworks. Note stone construction, powerhouse with flat 1954 roof in distance.

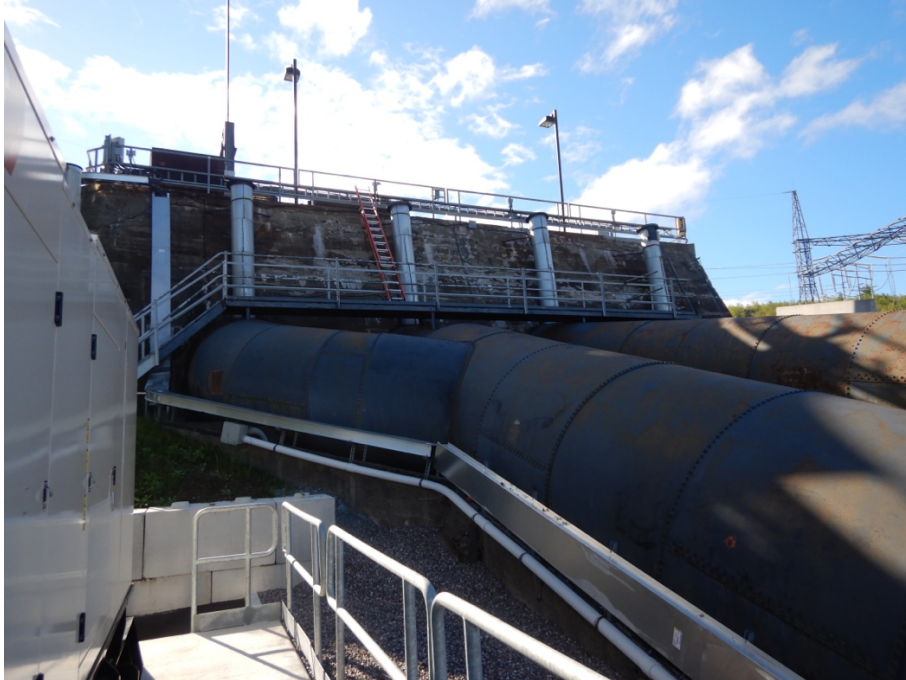
Figure 10: View of the headworks.

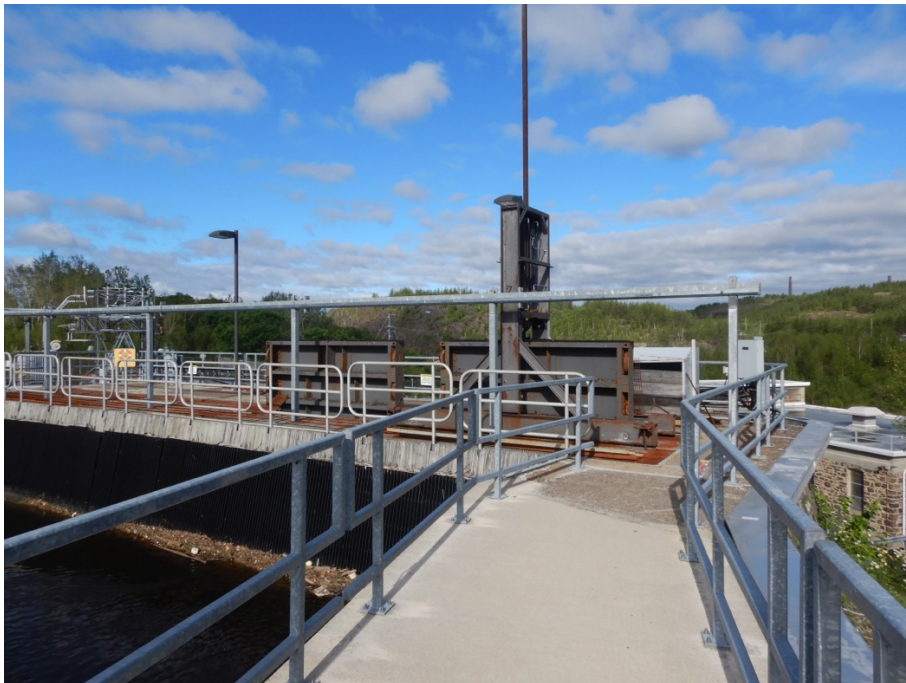
Figure 11: View of the headworks. Hoists are open to allow flow to penstock serving Unit 3.

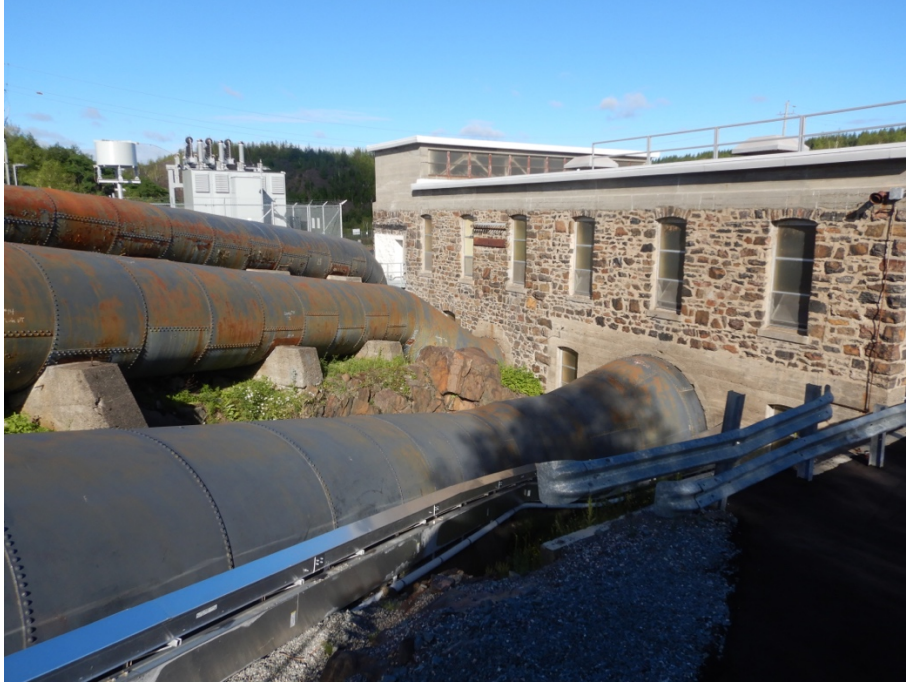
Figure 12: Penstocks as they enter the powerhouse. Unit 3 penstock, foreground, enters through concrete foundation wall. Note concrete saddles under Unit 2 penstock, and different entry angles.

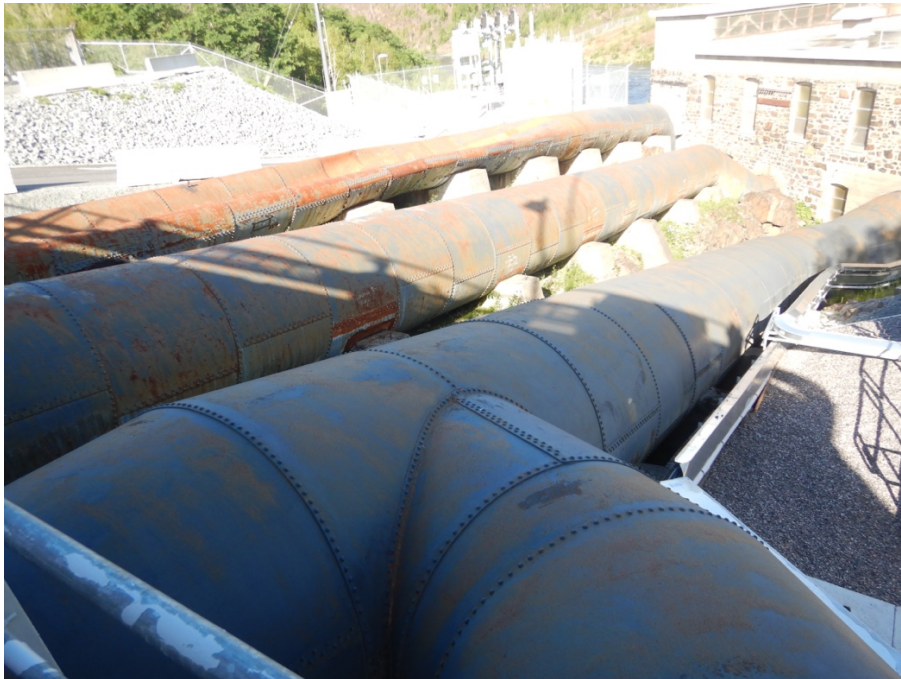
Figure 13: Penstocks showing coupling of two penstocks for Unit 3 in foreground. Note Unit 1 penstock in collapsed state.

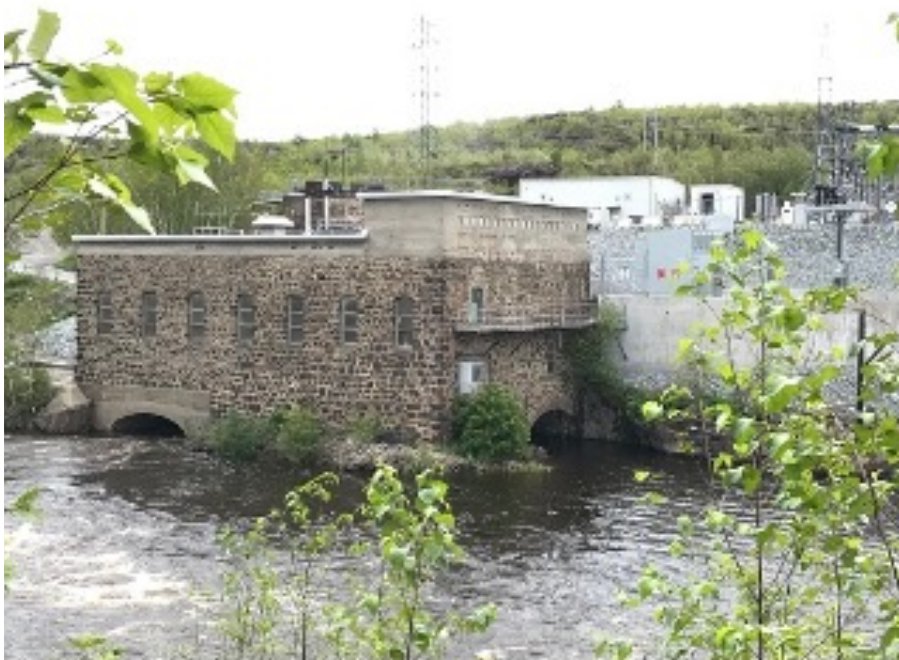
The tailraces include constructions associated with the powerhouse and its operation. Two tailraces were built for the outflow from the turbines. One, exiting the powerhouse on the west (downstream) end of the building, serves outflow from Units 1 and 2. The channel has been cut into the underlying bedrock, and the bedrock wall on the south side of the tailrace is visible. The opening for the tailrace is constructed of stone, segmental arch-shaped with stone voussoirs (Figure 15). This tailrace is noted on early blueprints as being between six and seven metres deep, and 6.7 metres wide. The second tailrace exists the powerhouse to the north, perpendicular to the flow of the river. The second tailrace exits the building through a segmented arch in the north wall, slightly larger than the first tailrace and constructed of concrete similar to the balance of the foundation for the 1915 addition (Figure 15).

Figure 15: View of the powerhouse from the north bank of the Wanipetei River showing west and north faces and post-1954 roof. The 1915 extension can be discerned by the difference in stonework and mortar.

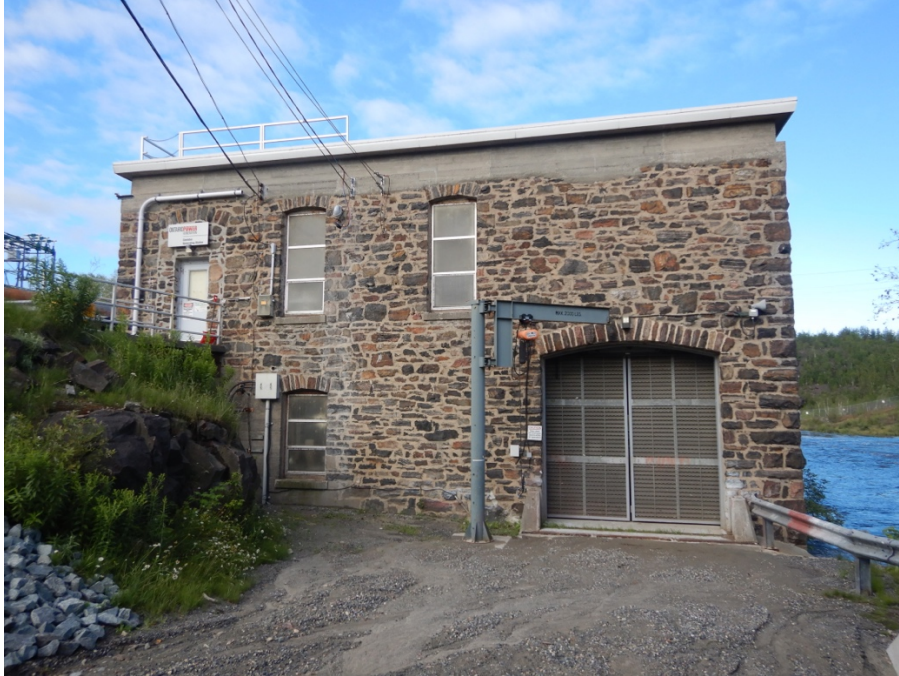
and a pedestrian door on the upper level (Figure 16). The openings for the windows and large service door appear to be original, while the upper level door has been resized to fit a smaller standard metal door. The door is accessed by a gangway from the embankment supporting the headworks. The service door is metal and is likely a replacement for the original. Concrete foundations of the extension are visible at ground level beneath the lower-level window, and rise to the height of the top of the window bay at the south end of the wall (Figure 17).

Figure 16: View of east wall, powerhouse. Window in Figure 17 on lower level to the left of the loading door.

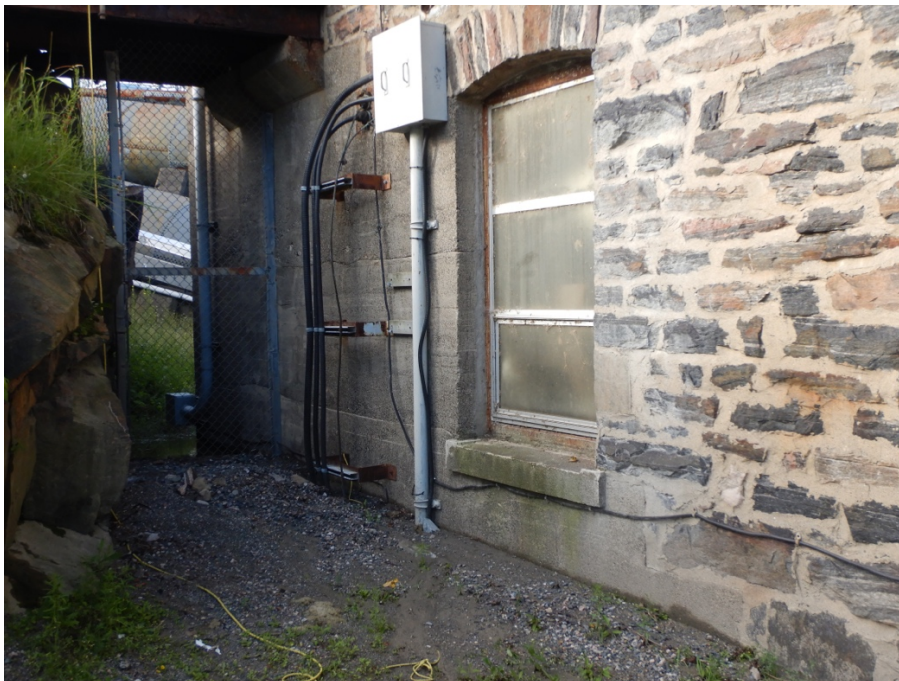
Figure 17: East wall transition from stonework to concrete foundation level. Penstocks can be seen through the chain fence.

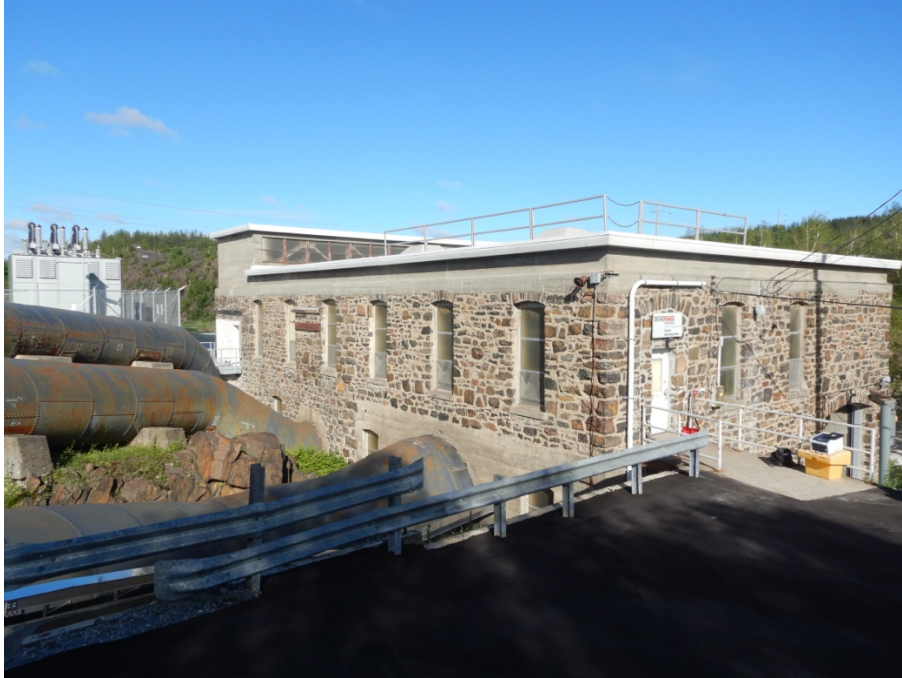
The south wall of the building is punctuated on the upper level by six windows and a pedestrian entry (Figure 18), and on the lower level by the three penstocks. There are also three windows on the lower level on either side of the penstocks for Units 2 and 3. The penstocks for Units 1 and 2 enter the building through openings set into the stonework beneath shallow arches (Figure 19). Concrete has been added around the intake at Unit 2 as a later repair (Figure 20). The Unit 3 penstock enters through a formed opening set into the concrete foundation wall (Figure 20). At the west end of the south wall there is a modified pedestrian entry. The low arch above the door is asymmetric to the current door reflecting the repurposing of an original window opening (Figure 21). The larger opening has been closed in with stone. Part of the exterior wall at this entry has been painted white and a horizontal band of tar is noted above the door but below the arch. Two vertical timber members are also attached to the wall at this point. The paint, wood and tar likely mark the level of a former shed roof, since removed. Two attachments to the exterior south wall are noted: a bracket for electrical service above the intake for Unit 2 penstock (Figure 22) and an alarm or speaker at the southeast corner (Figure 23). The electrical bracket is mounted on the stonework and is undated, while the alarm, mounted on the concrete portion of the wall, post-dates the 1950s reconstruction.

Figure 18: General view of east and south walls. Former transformer building / carpenter shed, now a transformer / switch facility in the upper left of photo.

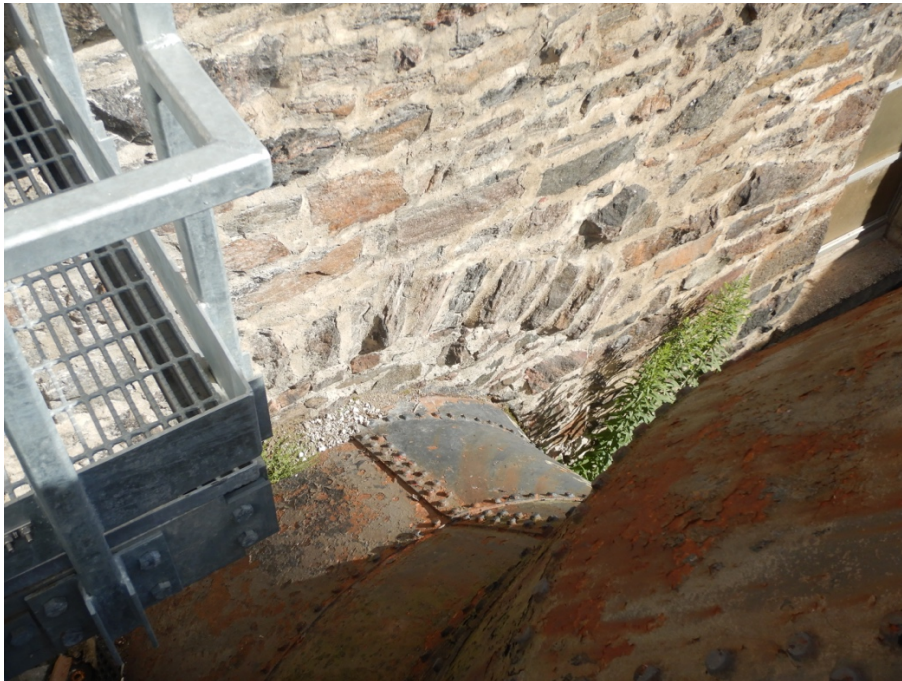
Figure 19: View of penstock to Unit 1, entry to powerhouse through stone arch. Note voussoirs and stone infill.

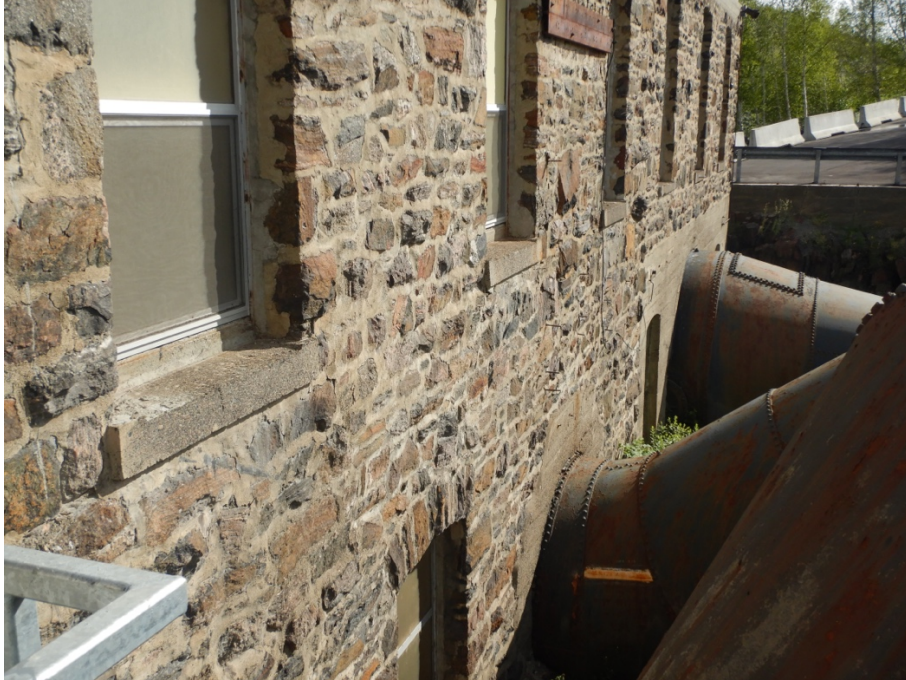
<p>foundation wall (Figure 20). The low arch above the pedestrian entry is asymmetric to the current door reflecting the repurposing of an original window opening (Figure 21). The larger opening has been closed in with stone. Evidence on the exterior wall (paint, roofing tar) likely mark a shed addition and removal, date unknown. Two attachments to the exterior south wall are noted: an undated bracket for electrical service above the intake for Unit 2 penstock (Figure 22) and a post-1950 alarm speaker at the southeast corner (Figure 23).</p> <p>The west exterior wall reflects several (undated) modifications due to changing technical requirements. In the original building, the upper level included two windows on the north side and apertures for wiring associated with two switches to the south (Figure 24). On the lower level there was one window below the switching apparatus, and a large service door toward the river. This door is aligned with the loading door in the east wall opposite. The outflow for Units 1 and 2 is through a single stone arch with stone voussoirs.</p> <p>Damage dating to a fire in 1954 led to replacement of the roof and gables. Also, post-fire reconstruction saw windows on the upper level closed in with stone; one completely closed, the other reduced to fit a standard metal door. A metal walkway was installed to provide access to the door and exterior equipment.</p> <p>One of the more striking aspects of the powerhouse is the contrast in materials used in the original and in the post-1952-fire reconstruction. The original four bay building had a wooden gable roof (Figure 14). The roof was extended to the east in 1915. The 1952 fire destroyed the roof and the upper courses of stonework on the walls. The gable roof was demolished and replaced with a flat roof constructed of concrete panels over steel girders (Figure 27). The roof was stepped up at the western end to accommodate switching equipment. A concrete cap to the exterior walls was built up to support the new roof and stabilize the stonework below. In the elevated western section, translucent lights were placed in the east face overlooking the rest of the roof to provide ambient light to the interior (Figure 28). West wall alterations include formed elements for six transformers and switchgear (Figure 25). Three apertures and anchors are provided for each switch operating in the powerhouse, along with metal brackets to support transformers and other controls. Equipment for four switches was in place during the 2016 property inspection (Figure 26), however, all exterior equipment had been removed by July 2020.</p> <p>Overall, the reconstructed roof changes the appearance of the original powerhouse to a blockier profile.</p>

Figure 20: Entry of Unit 2 penstock, with concrete patching, and Unit 3 penstock through concrete foundation wall of the 1915 extension. Note windows in lower level.

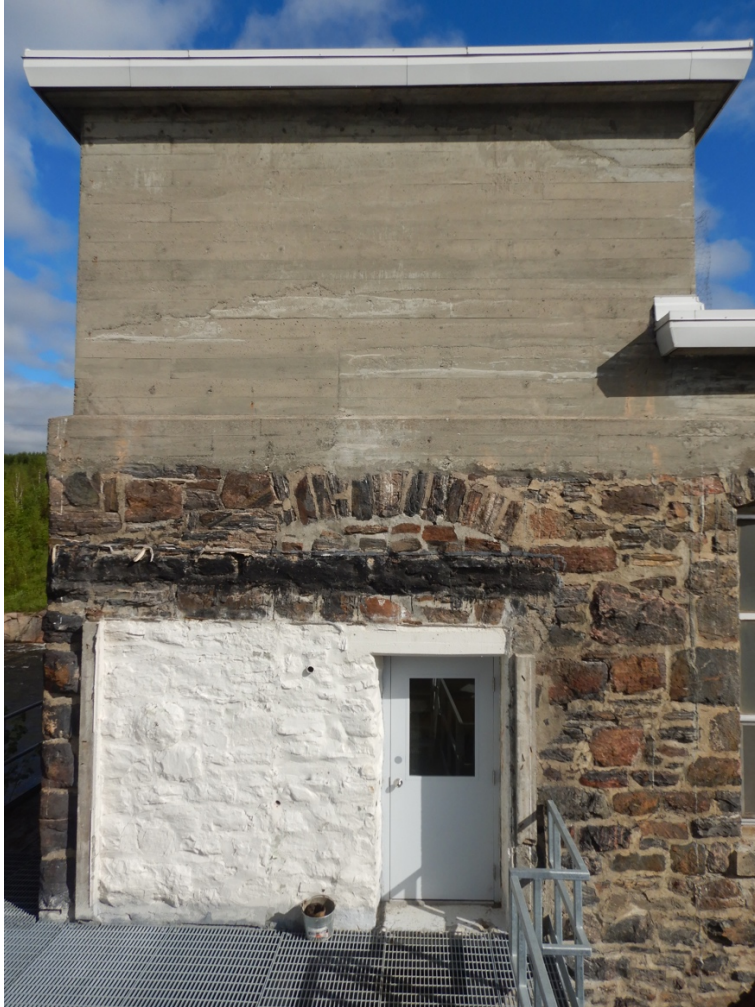
Figure 21: South wall, west end. Repurposed window to entry door, window arch above horizontal tar line marking former shed roof, and whitewashed wall section.

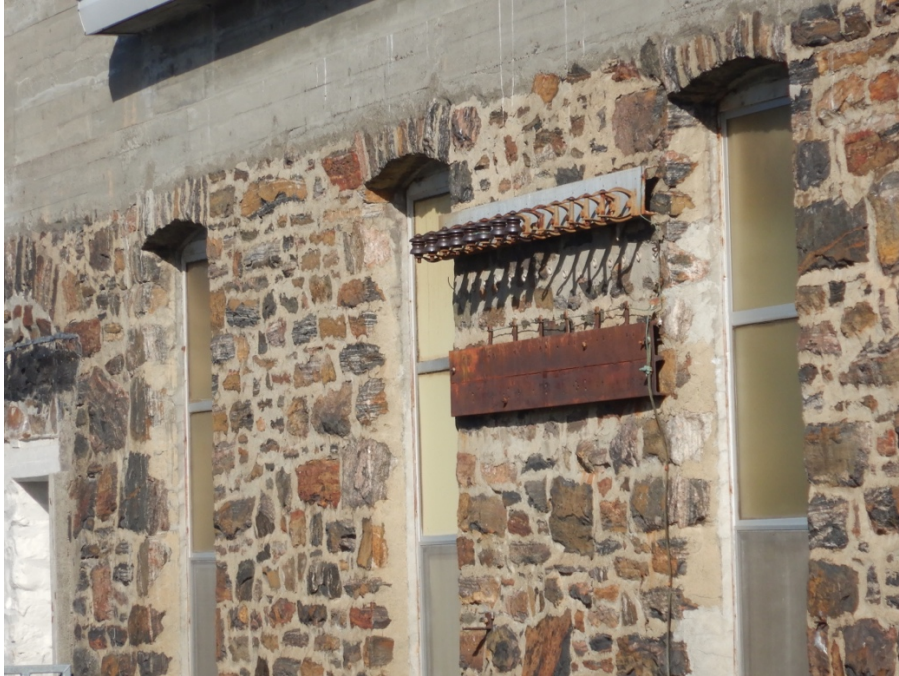
Figure 22: South wall showing wiring bracket. Note 1950s concrete wall beginning directly above the original window arches.

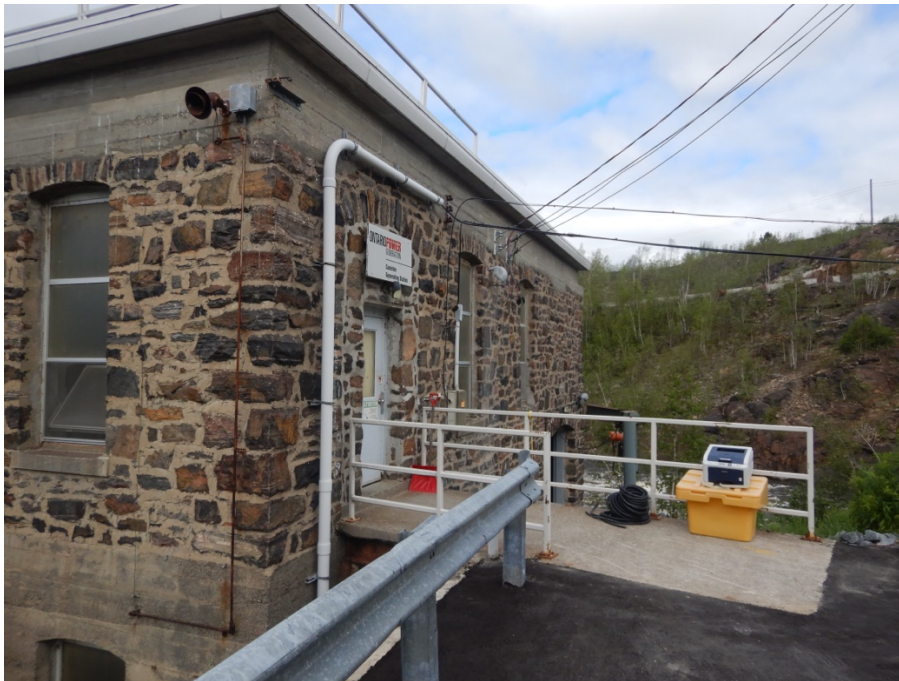
Figure 23: South and east walls

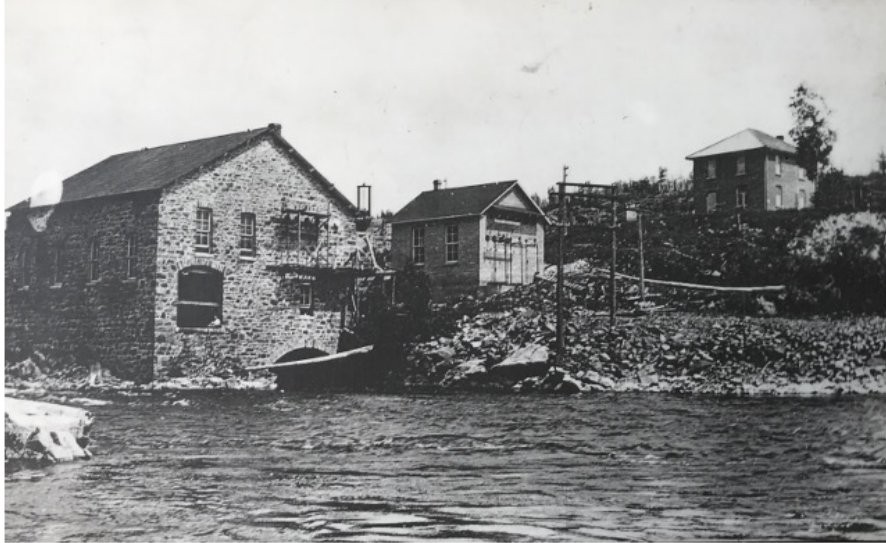
Figure 24: pre-1915, showing original powerhouse, transformer building and a staff residence on the hill. Source, OPG. Reproduced from Unterman McPhail (SCRR 2017).

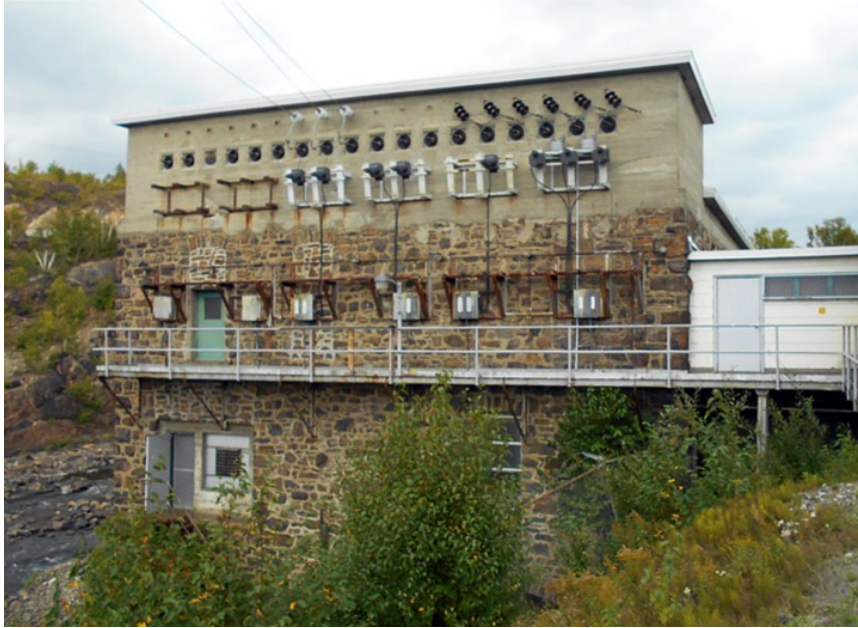
Figure 26: 2016 West wall of powerhouse. Reproduced from Unterman McPhail (SCRR 2017).

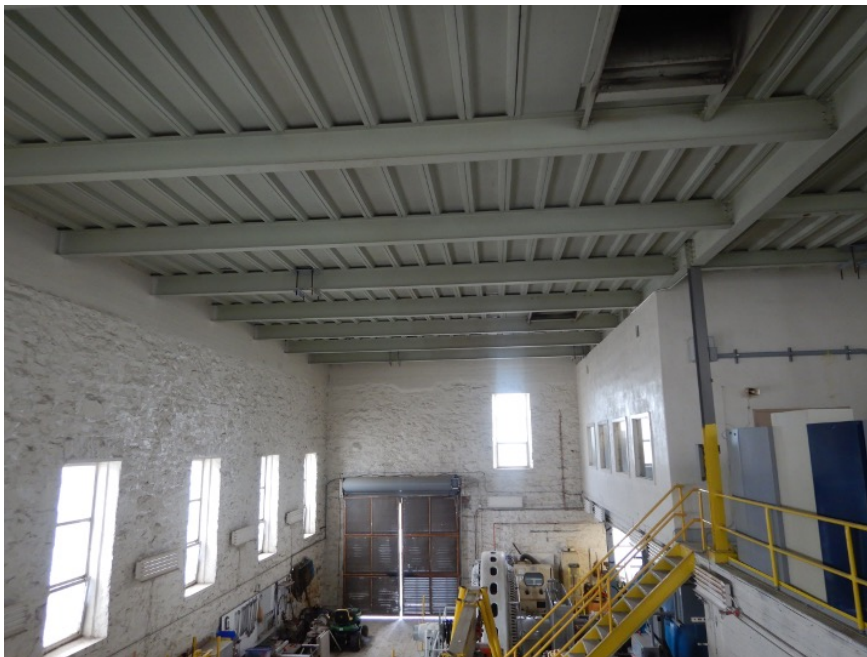
roof, and likely damaged some of the upper courses of stone. The gable roof and possibly the upper courses of stonework were demolished and replaced with a flat roof constructed of concrete panels over steel girders (Figure 27). The roof was stepped up at the western end to accommodate switching equipment. A concrete cap to the exterior walls was built up to support the new roof, and possibly to stabilize the stonework below. In the elevated western section, translucent lights were placed in the east face overlooking the rest of the roof to provide ambient light to the interior (Figure 28). Overall, the reconstructed roof changes the appearance of the original powerhouse to a blockier profile.

Figure 27: view of powerhouse interior showing ceiling form.

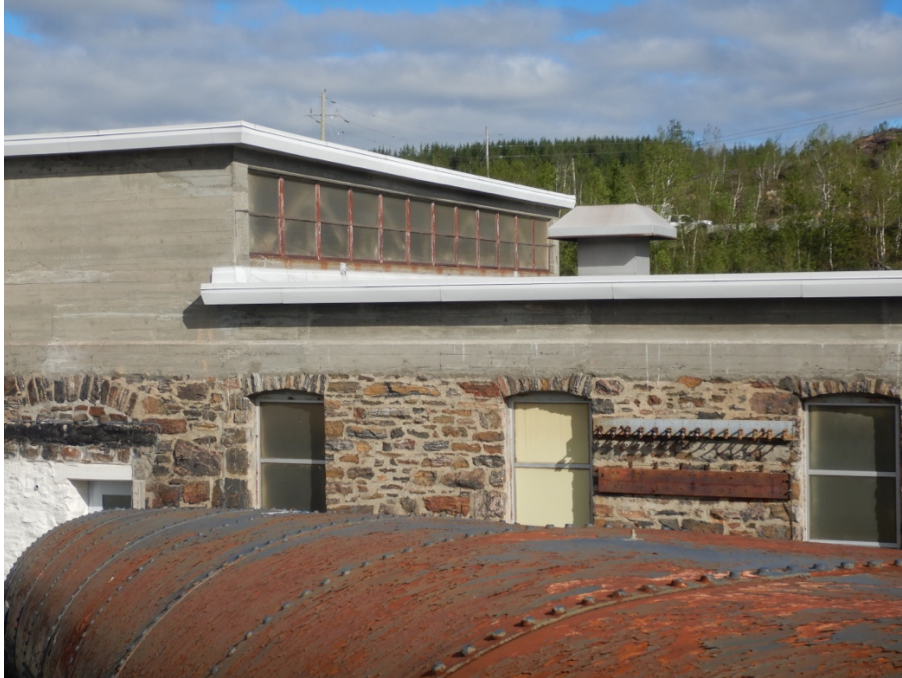
Figure 28: View across penstocks showing powerhouse roof, with lift and lights on east face.

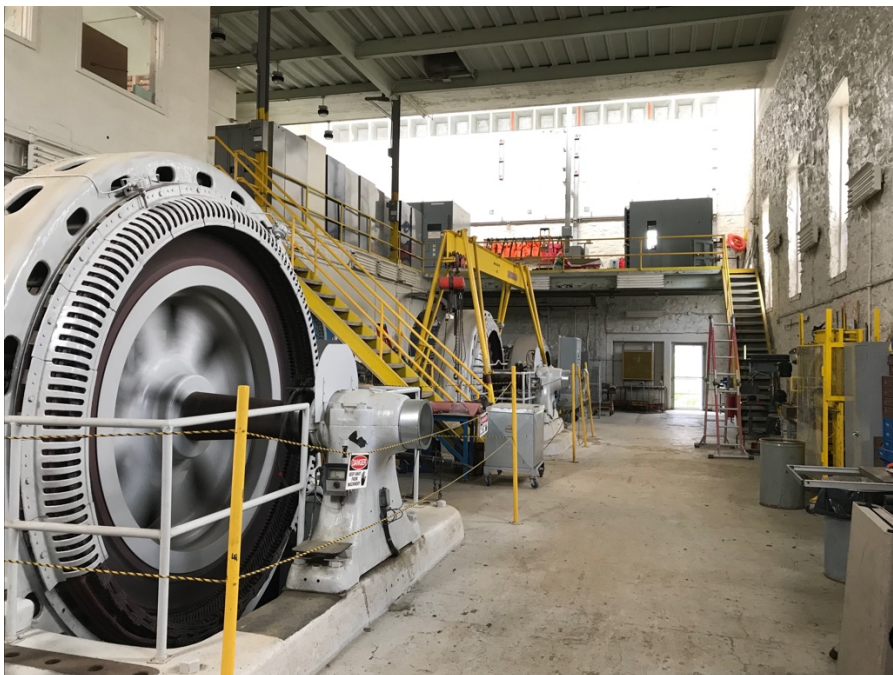
Figure 29: Powerhouse interior 2020. Unit G1 foreground, Unit G2 beneath yellow crane, and Unit G3 at end, next to service door (open) in distance.

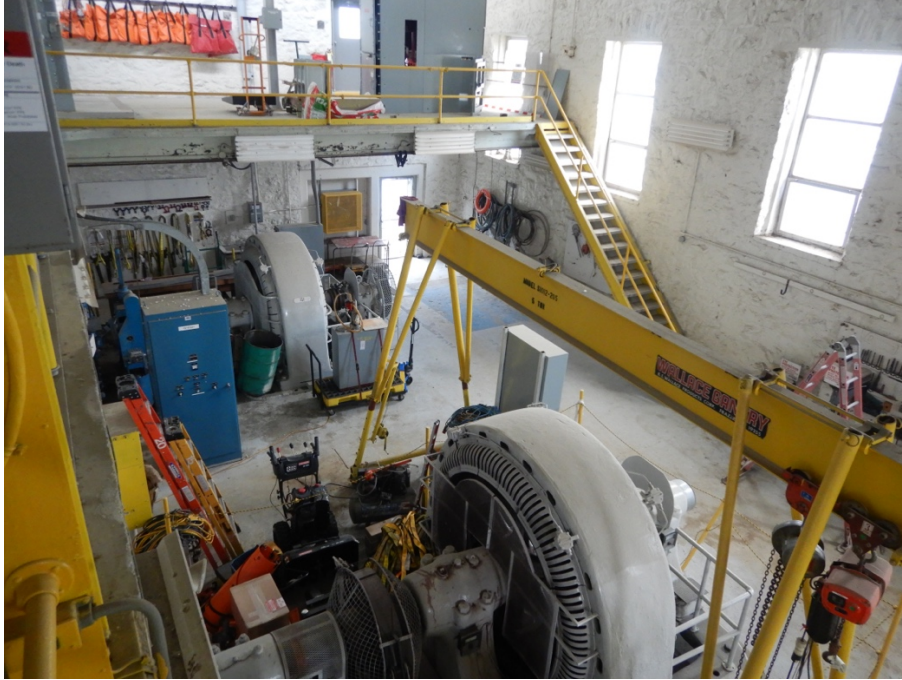
Figure 30: View from mezzanine. Unit G1 to left, Unit G2 to right. Stairs to mezzanine along south wall.

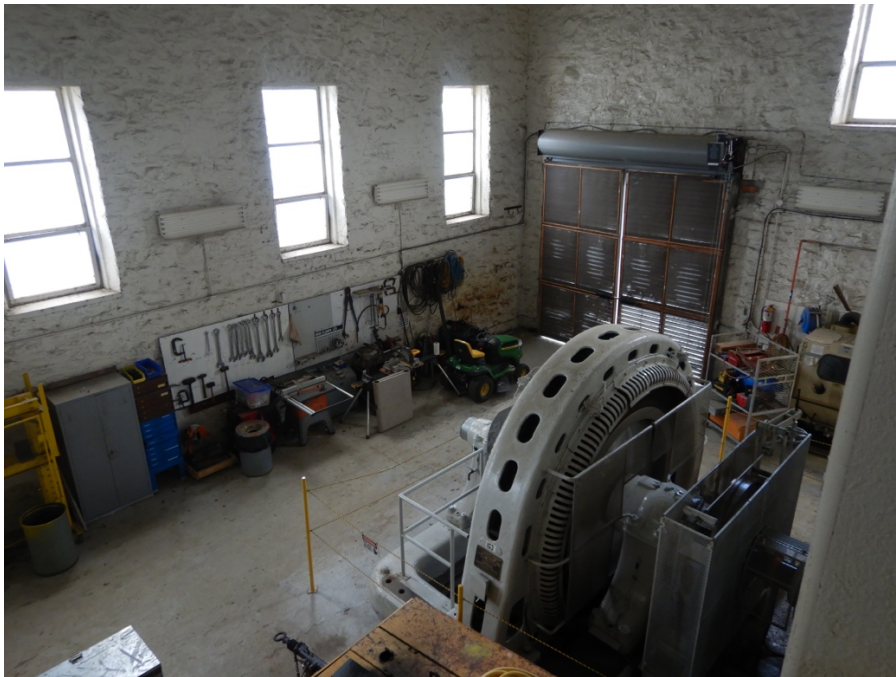
Figure 31: View from mezzanine. Unit G3 in foreground, service door to right.

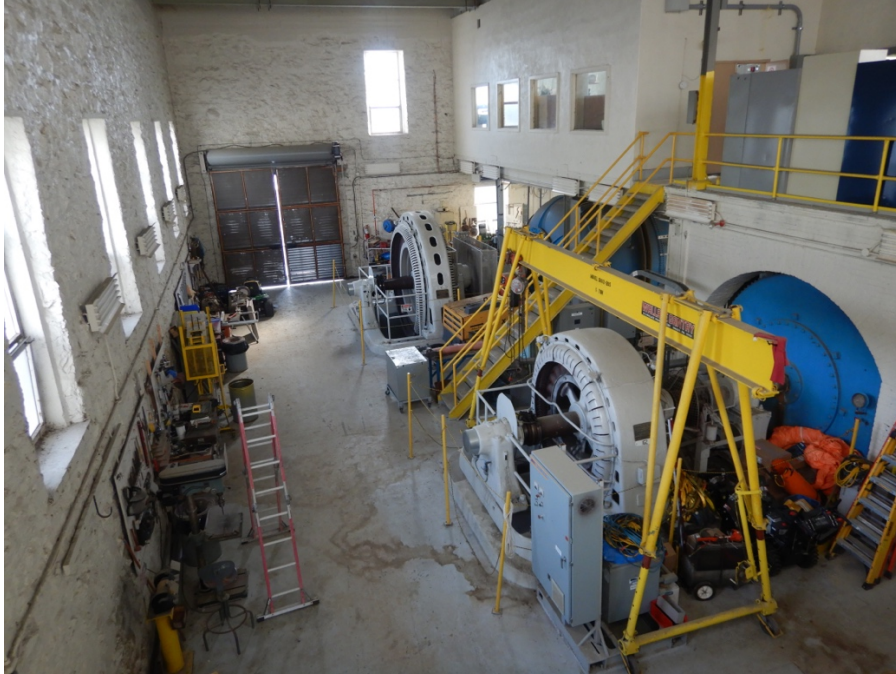
Figure 32: View from top of west stairs showing Units G2 and G3 as well as upper mezzanine.

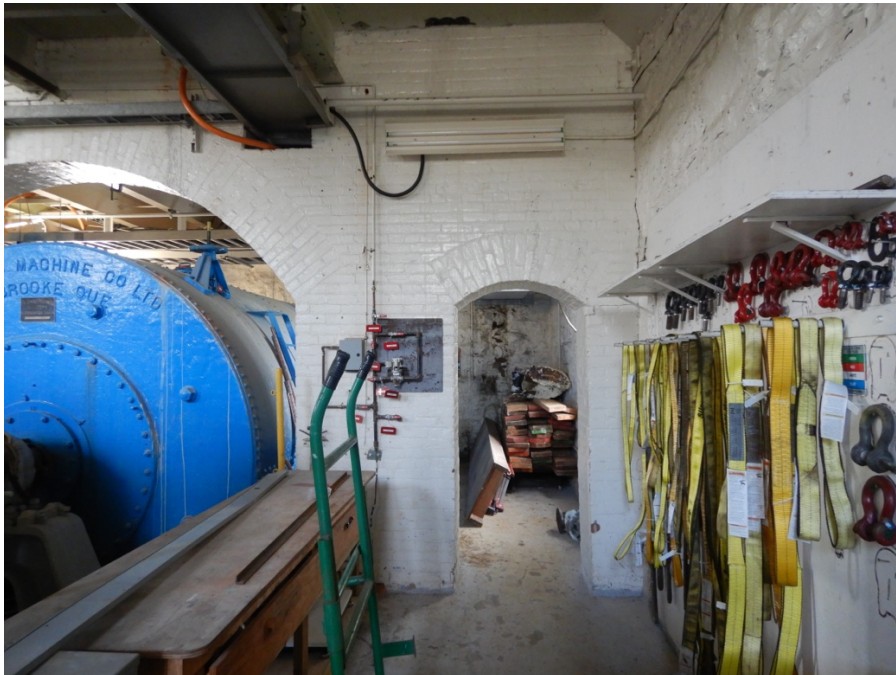
Figure 33: Powerhouse interior detail showing brick partition supporting mezzanine, brick arch above door, and Unit 1 turbine.
