**Heritage Impact Assessment  
Coniston GS Life Extension Project Project,  
Wanapetei River, City of Greater Sudbury,  
District of Sudbury, Ontario.**

CHIA Report  
November 21, 2022

Heritage Impact Assessment Report

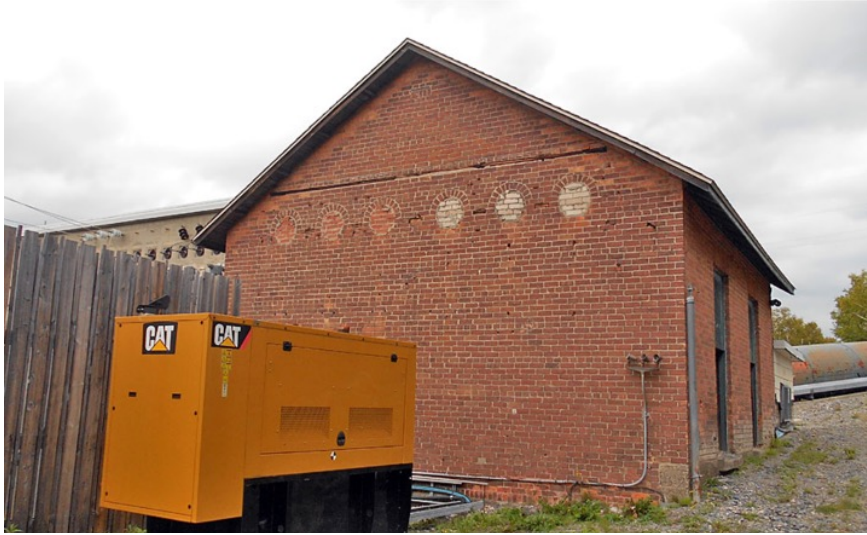
Figure 34: Former Transformer House, later Carpenter Shop, demolished between 2016 and 2022. Reproduced from Unterman McPhail (SCRR 2017).

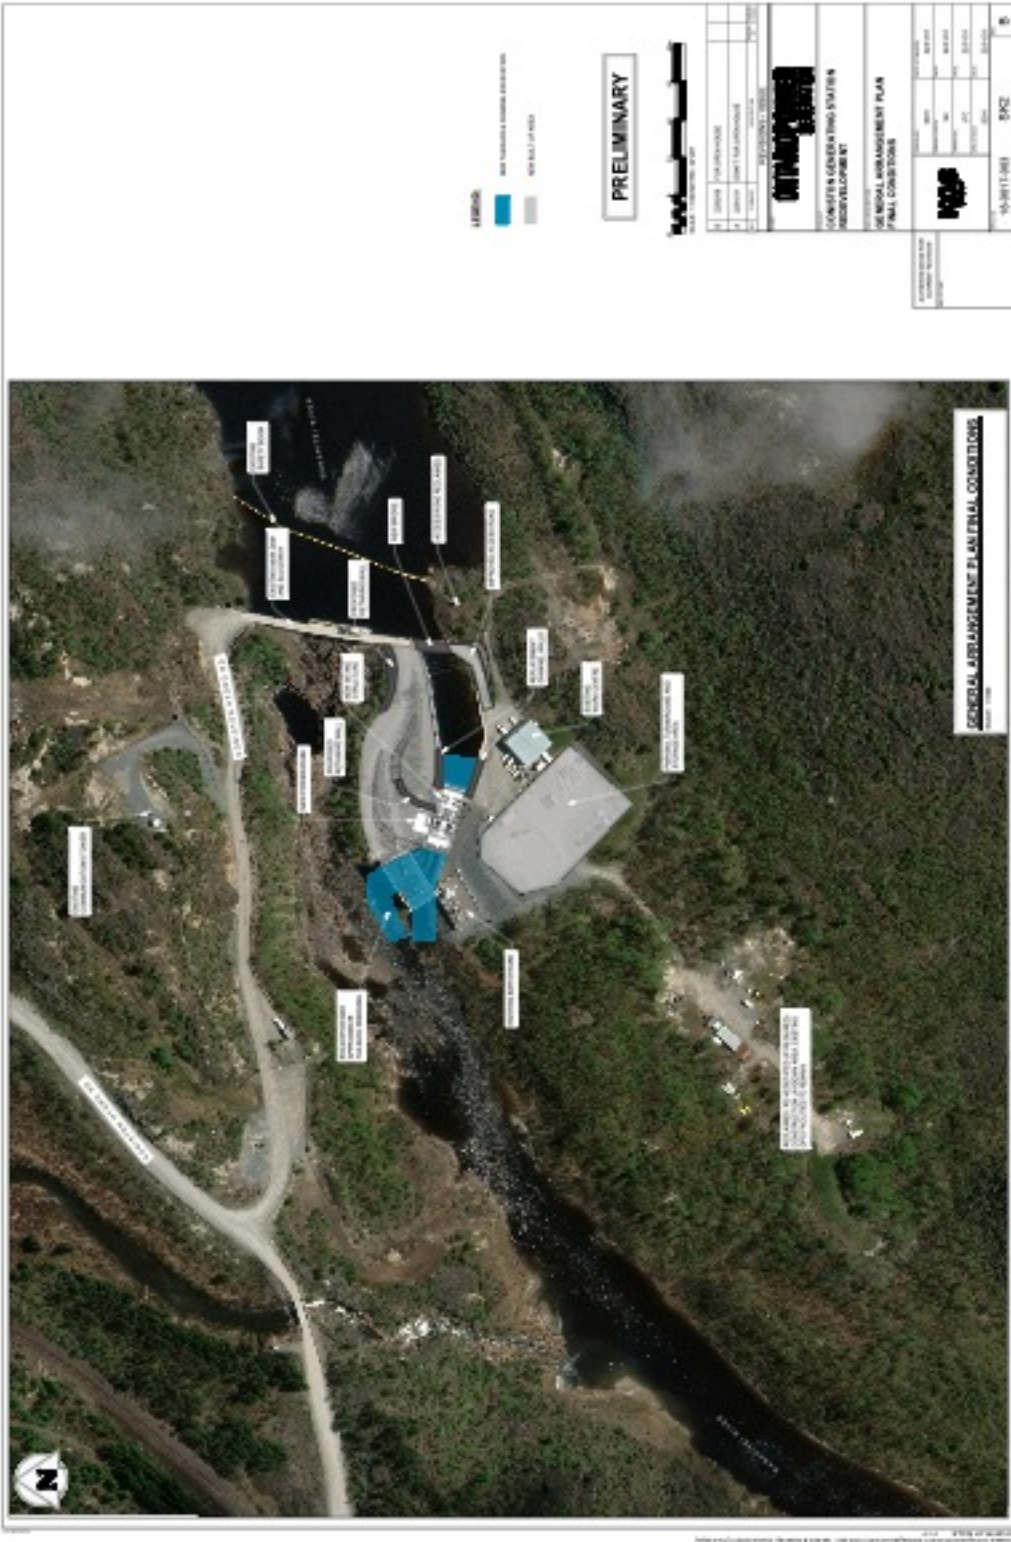
Figure 35: Draft Final Site Design for the Coniston GS Redevelopment.
