Environmental Working Group

Monthly Report

December 2013

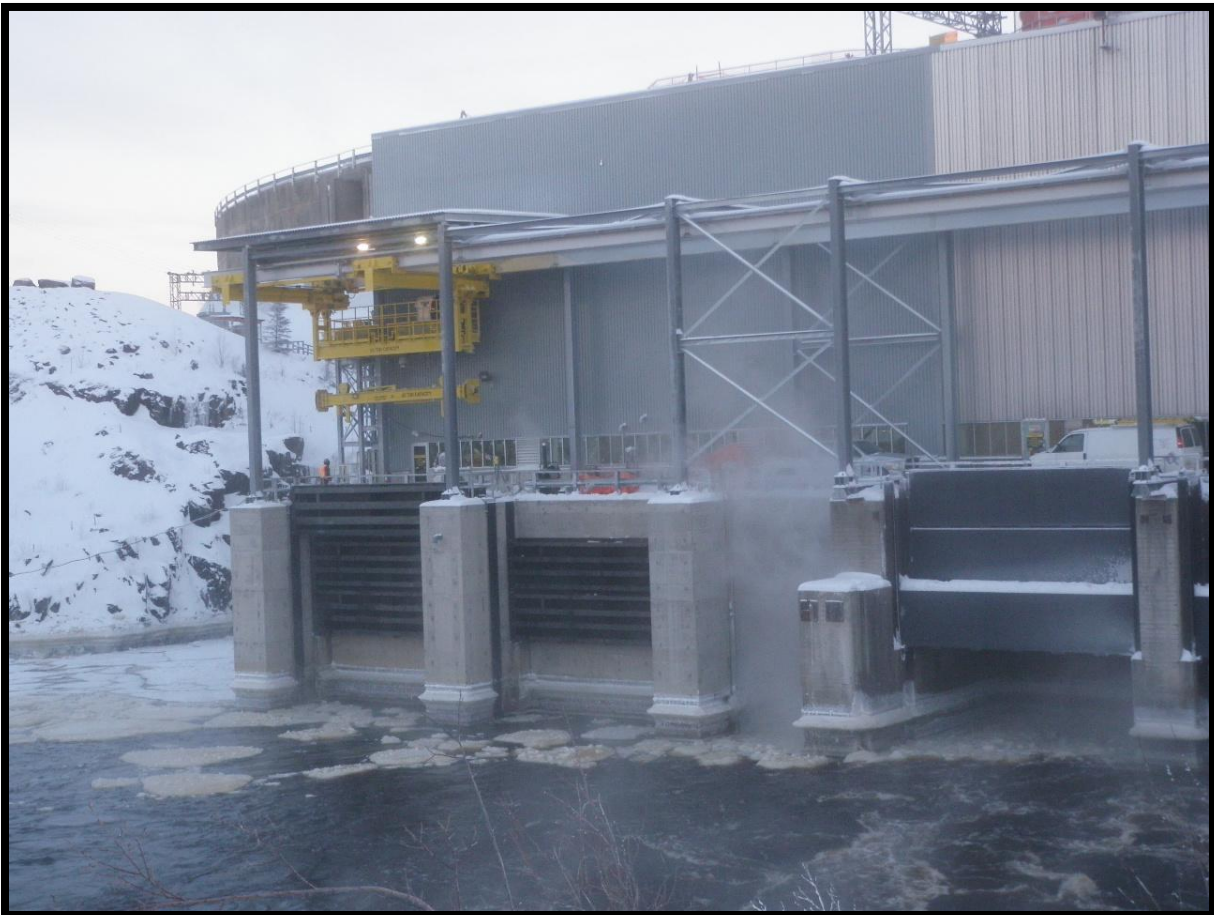
Figure 1: Little Long Overview

- The focus of work this month was subsystem testing and commissioning, Unit testing and commissioning, and Transfer of Control (TOC) documentation.
- Grinding of the discharge ring to increase clearances was declared complete, measurements were taken at November month-end, and the clearances were determined to meet the required tolerance. The measurements were verified and clearances were accepted on December 5.

- Unit testing occurred between December 5 and month-end, covering a large number of operational scenarios.
- Very minor rubbing (runner / discharge ring contact) was detected during the 100% load rejection test. Andritz ground and buffed the areas affected.

- Corrective work to address deficiencies identified during testing is ongoing.
- KAP and Andritz electricians continued to work on addressing punch list items.

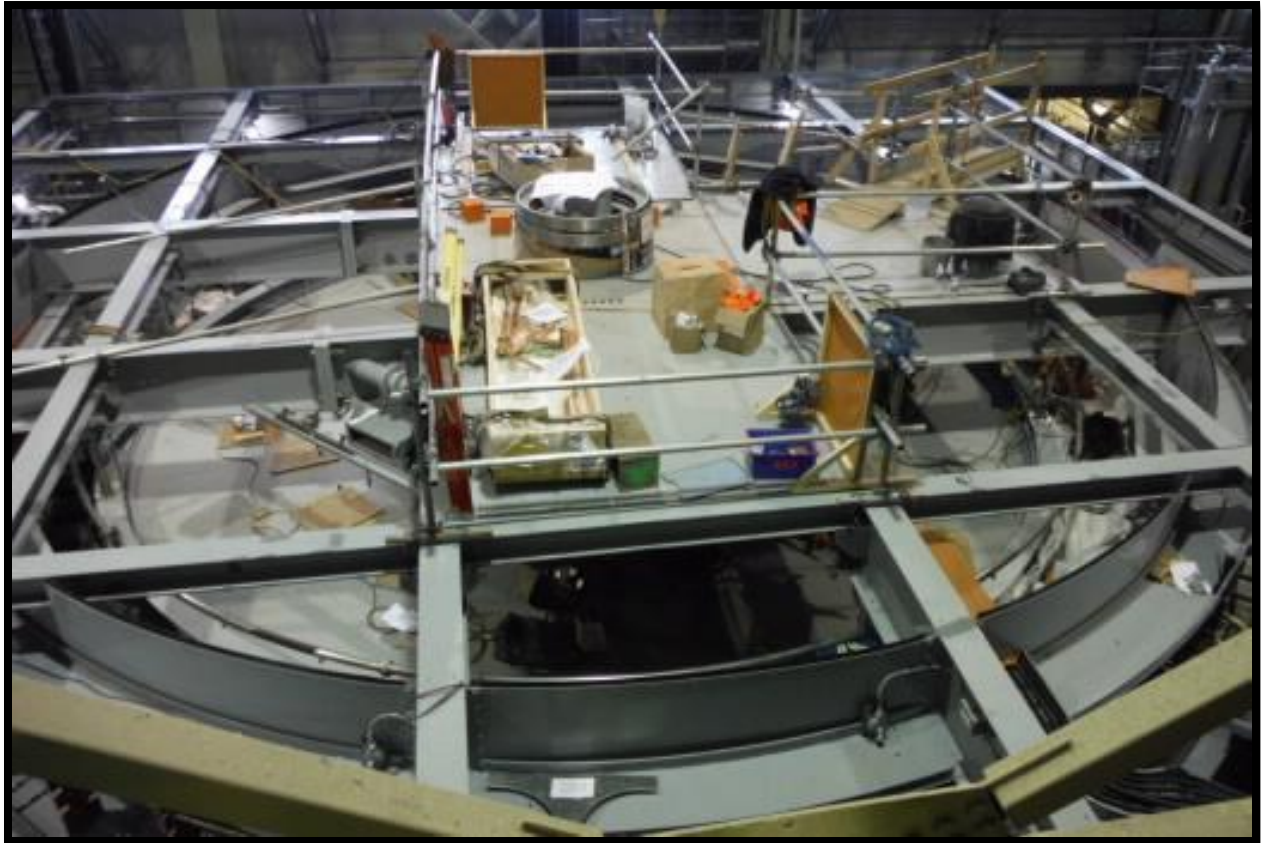
Figure 2: Harmon Unit 3

- Andritz completed all unit alignment activities.
- Andritz started installing the generator enclosure (Figure 2).

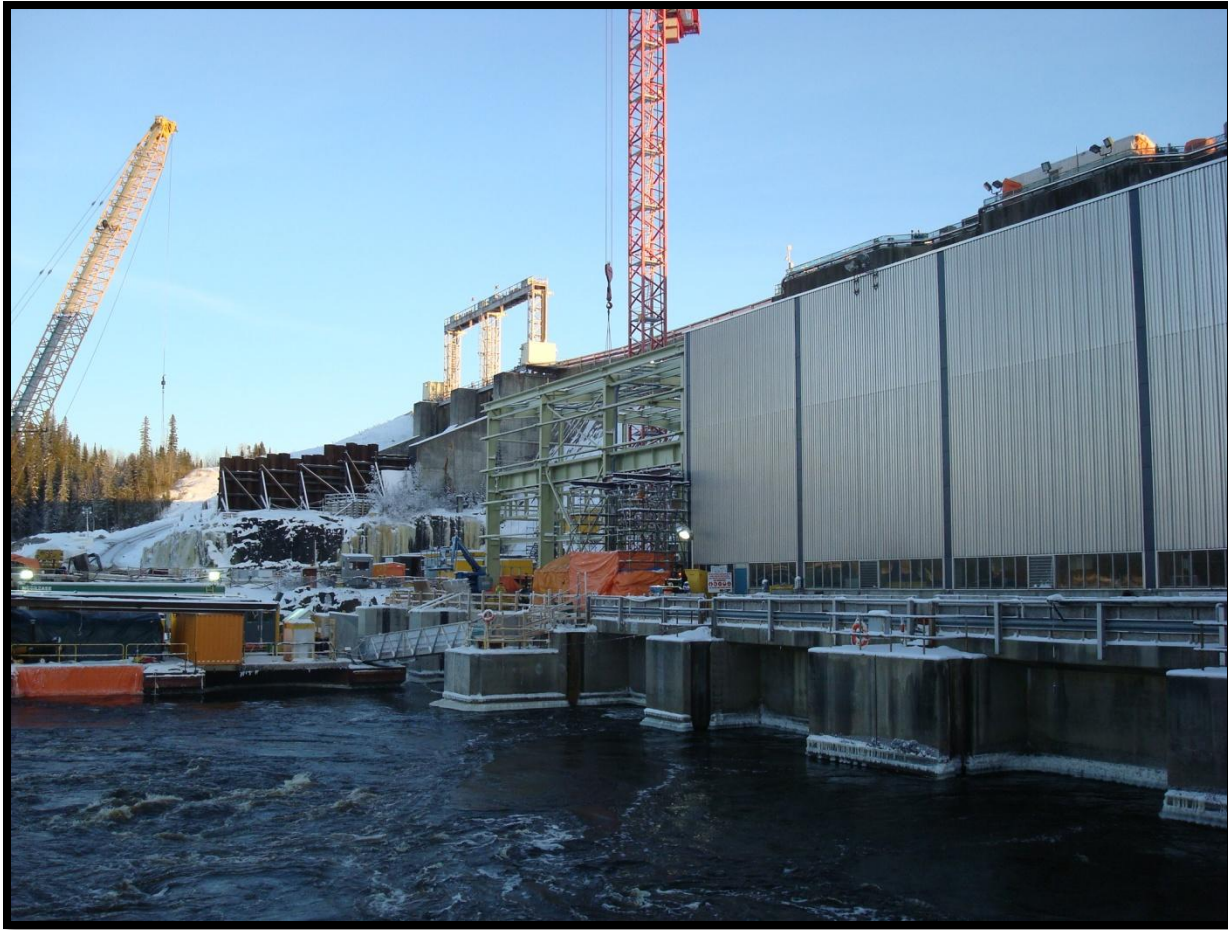
Figure 3: Kipling Superstructure erection

- 223 m³ of concrete was poured this month, bringing the total poured to date to 11,260 m³ of 11,885 m³.
- The superstructure erection is complete and the inner cladding and temporary roof was installed (Figure 3).
- Removal of fill from Cell 1 of the cellular cofferdam was completed to the level required to install the cell template. The cofferdam crew demobilized and cofferdam removal is planned to resume in 2014.
- Andritz prepared rotor parts (stored in the Service Bay) for assembly and have started welding the rotor spider.
- Preparations to assemble the Unit 3 runner between Units 1 and 2 are under way.
- KAP continued to install service air and depression air lines on the generator floor.

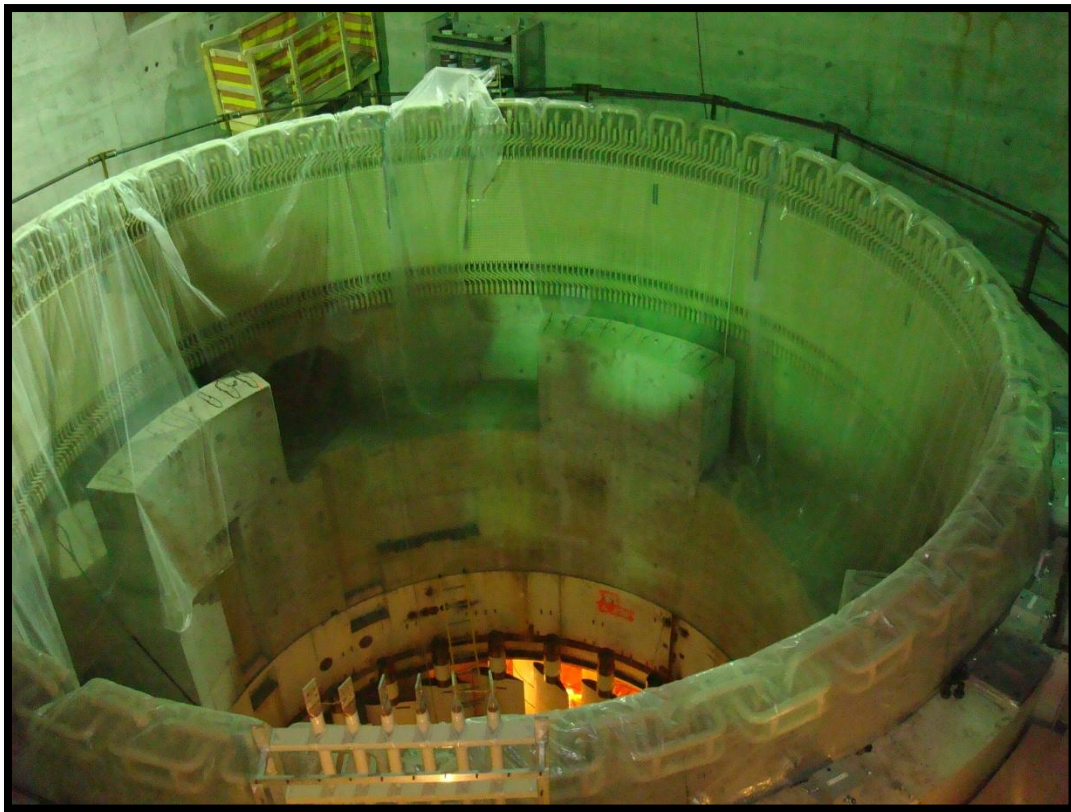
Figure 4: Smoky Falls Unit 1 Stator & Wicket gates installed

- At Unit 1, Alstom installed wicket gate levers and the outer head cover. The bolts between the bottom ring and the stay ring were torqued. Alstom completed rotor pole installation and leveled them (Figure 4);

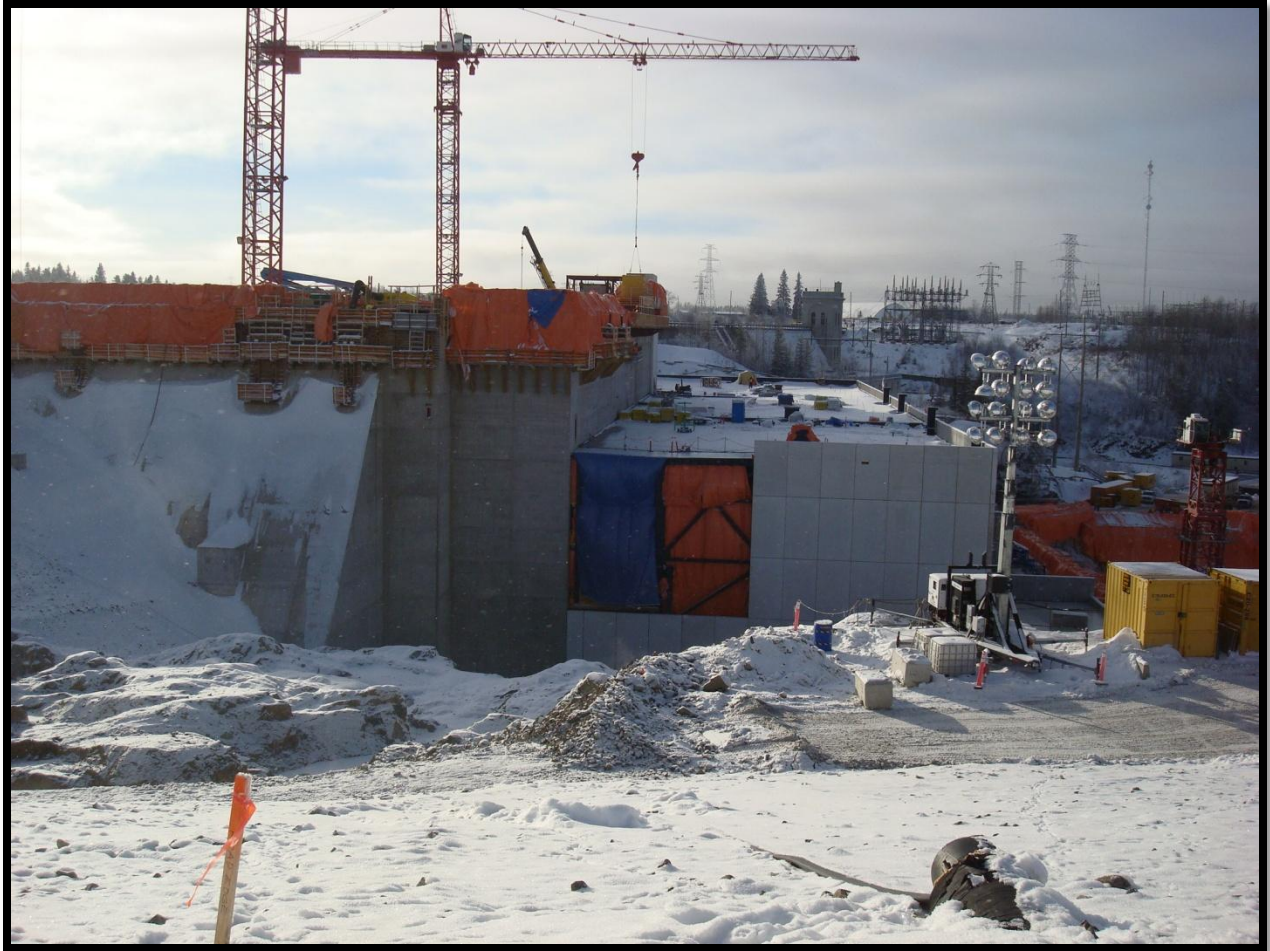
Figure 5: Smoky Falls Exterior Overview

- Earthworks activities around the East gravity dam progressed in the month, with rockfill placement and slope trimming on the downstream side. Backfilling has started on the upstream side of the East gravity dam (Figure 5).

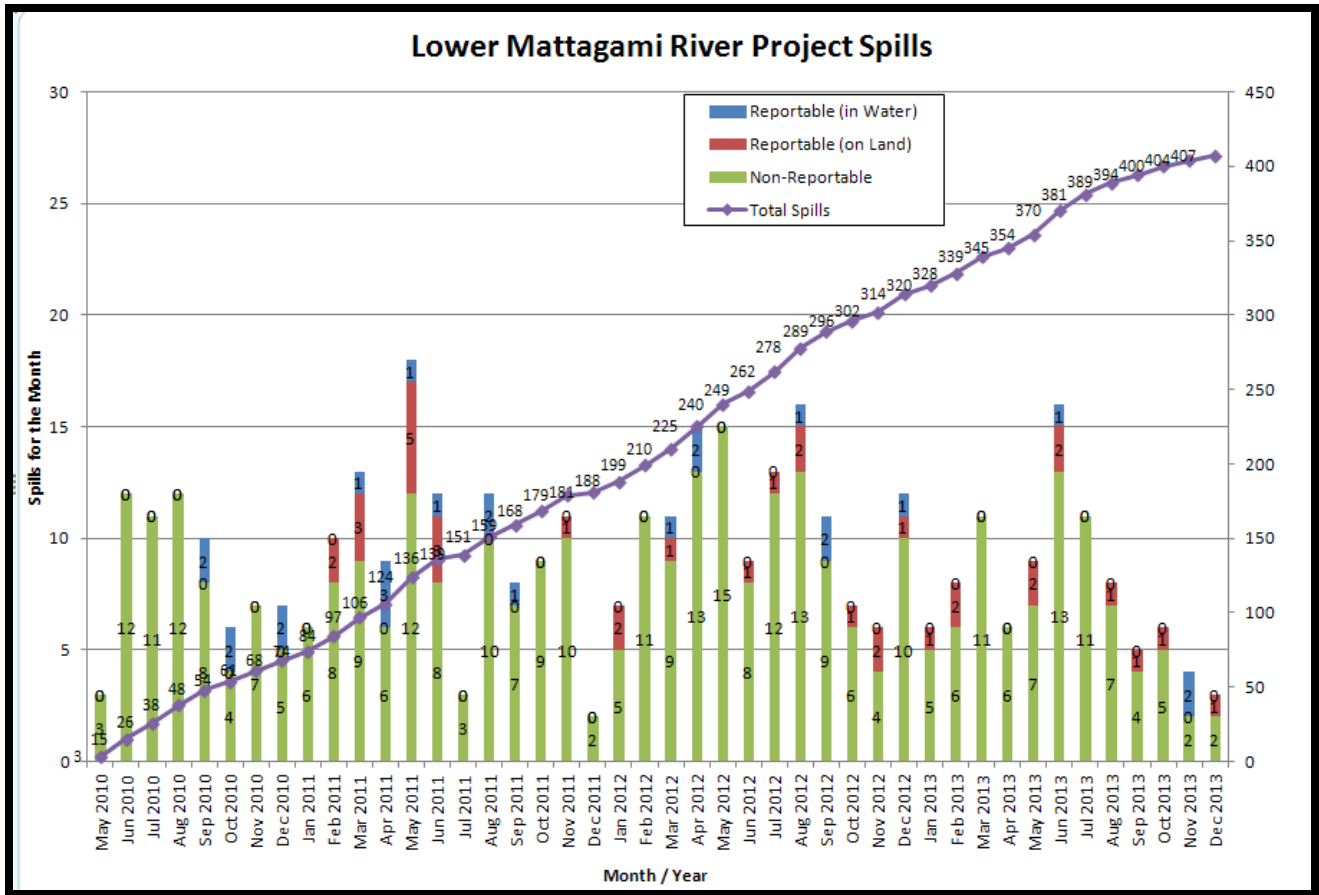
Figure 6: Lower Mattagami River Project spills

SPILLS			
No. of Spills:		3; Spill Reports 405-407 (see Figure 6 for LMRP spills breakdown).	
Classification of Spills:		<p><u>KAP Project Classification</u> Minor – 1 Moderate – 2 Major – 0 To Water - 0</p> <p><u>MOE Classification</u> Non-reportable - 2 Reportable to MOE</p> <ul style="list-style-type: none"> - Class C – 1 - Class B – 0 - Class A – 0 	
Reportable Spills			
No.	Quantity /Product Spilled	Spill Site	Reason for being Reportable
1	2-3 m ³ /Sand	Harmon – Marine Access Pad Removal	The crusher crew had installed frost fighters on the track screener on the previous day to help warm the oil prior to moving it for use the next day. Overnight, the frost fighters had not been filled and stopped working, which caused the hydraulic oil to become thicker, causing stress on the pumping system to the motor. This stress increased the pressure inside the engine, which in turn broke the seal on the engine. This caused the oil in the engine to leak out, onto the ground.

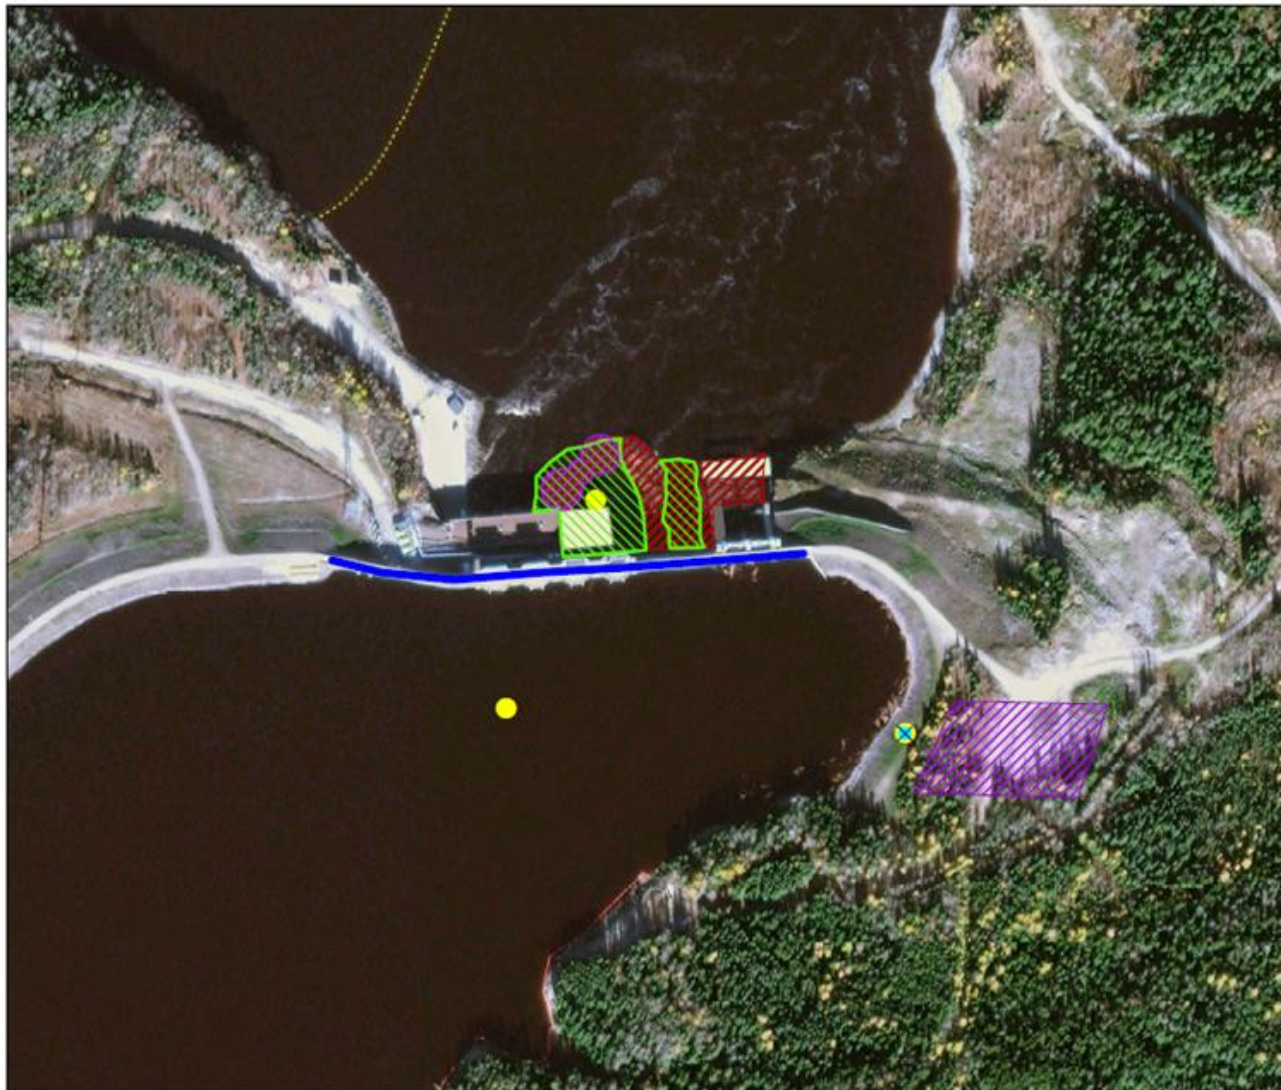
Figure 10:
Lower Mattagami River Project
Kipling GS - Permits

REQUESTS FOR INFORMATION (RFIs)			
No. Reviewed:	0	List:	n/a
No. Sent to KAP:	0	List:	n/a
See figures 8 to 13 below for site location of the permits that have been or are pending approval.
