**Environmental Working Group**

**Monthly Report**

**February 2014**

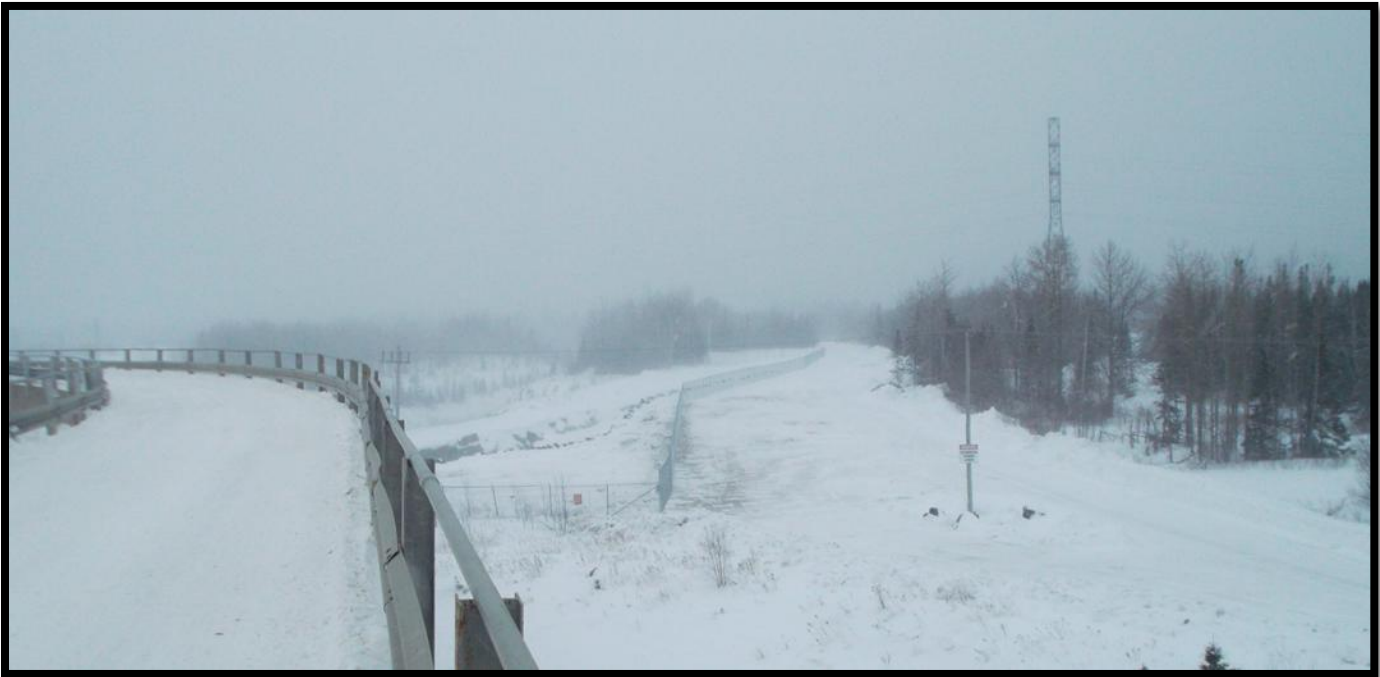
Figure 1: Little Long Permanent Fence

- The focus of work this month was on deficiency (i.e. punch list) remediation and Transfer of Control (TOC) documentation.
- Generator floor painting was completed.
- Installation of the Permanent Fence was completed.
- The current forecast completion date for punch list item remediation is March 14.

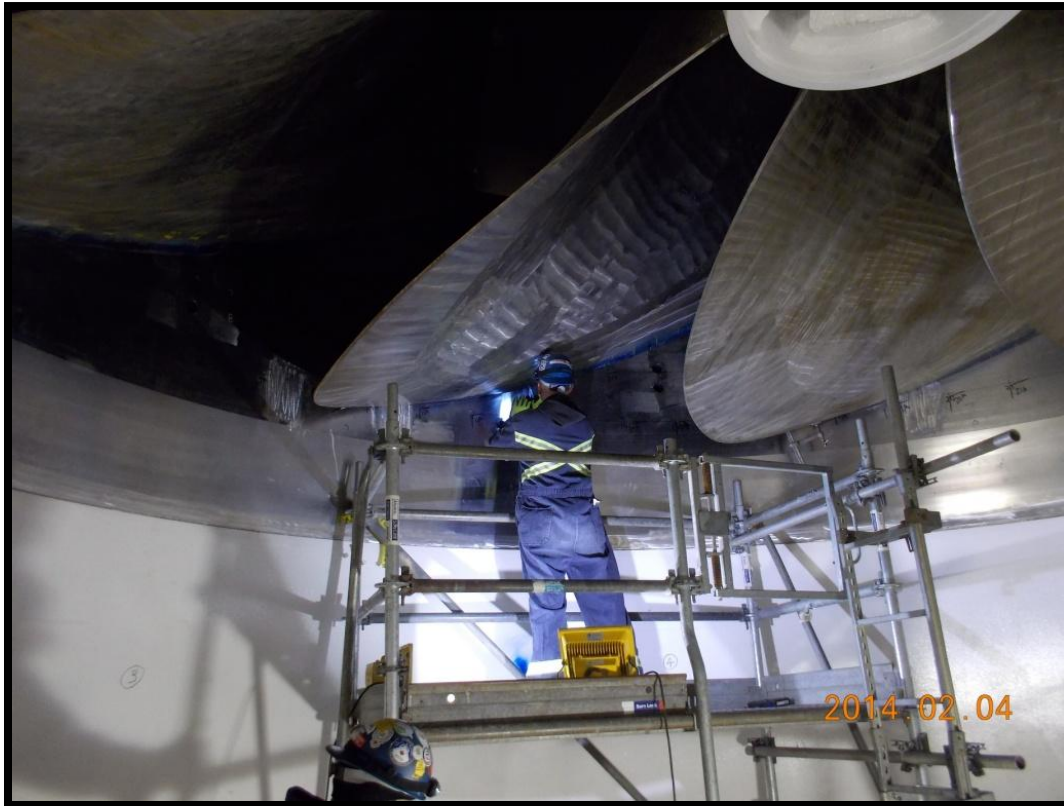
Figure 2: Harmon runner blade inspection

- Turbine and generator systems piping installation was completed.
- Pressure testing and flushing was completed for shaft seal piping.
- Measurements and adjustments of various turbine and generator components were completed throughout the month (Figure 2).

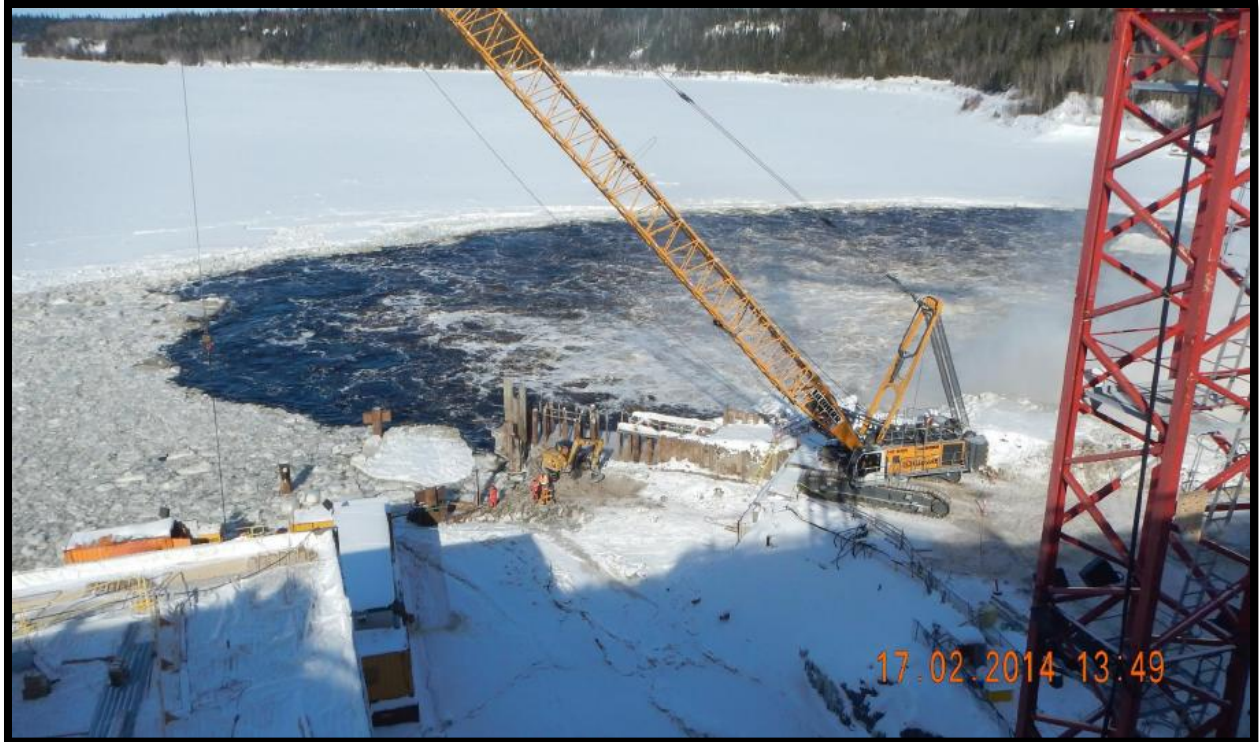
Figure 3: Kipling Cofferdam Removal

- Structural concrete was completed at Kipling this month. Some minor grouting and concrete repairs remain.
- Cofferdam cell 1 sheet piles and spud piles were completely removed. Clamming of fill continues in the cofferdam footprint (Figure 3).

- EWG was concerned with the lack of turbidity monitoring data during the Kipling Cofferdam removal process (clamming of cells). At the end of January the water probes froze and data was not able to be collected for a couple weeks.

Action Required: KAP to reinstall probes and ensure data is recorded.

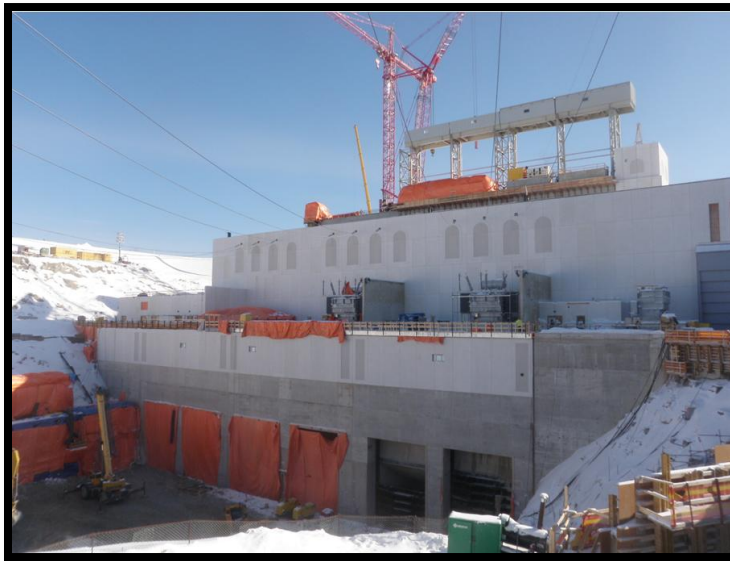
Figure 4: Smoky Falls Overview

- 156 m<sup>3</sup> of concrete was poured this month in the service bay, powerhouse, and intake areas, bringing the total poured to date to 141,066 m<sup>3</sup> of 141,832 m<sup>3</sup>. The remaining concrete at Smoky Falls consists of finishing details, small slabs and walls (Figure 4).

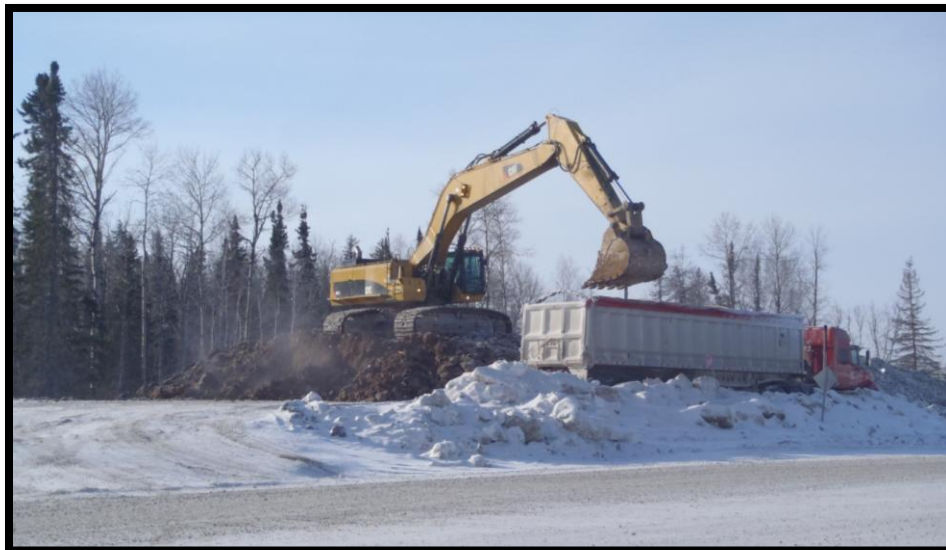
Figure 5: Removing the soil stockpiles at Smoky Falls

- The EWG were also notified that KAP started removing the contaminated soil stockpiles at Smoky Falls on February 26 (anticipated completion date is March 4).

- On February 26, 2014, KAP started removing the soil stockpiles at Smoky Falls (Figure 5).

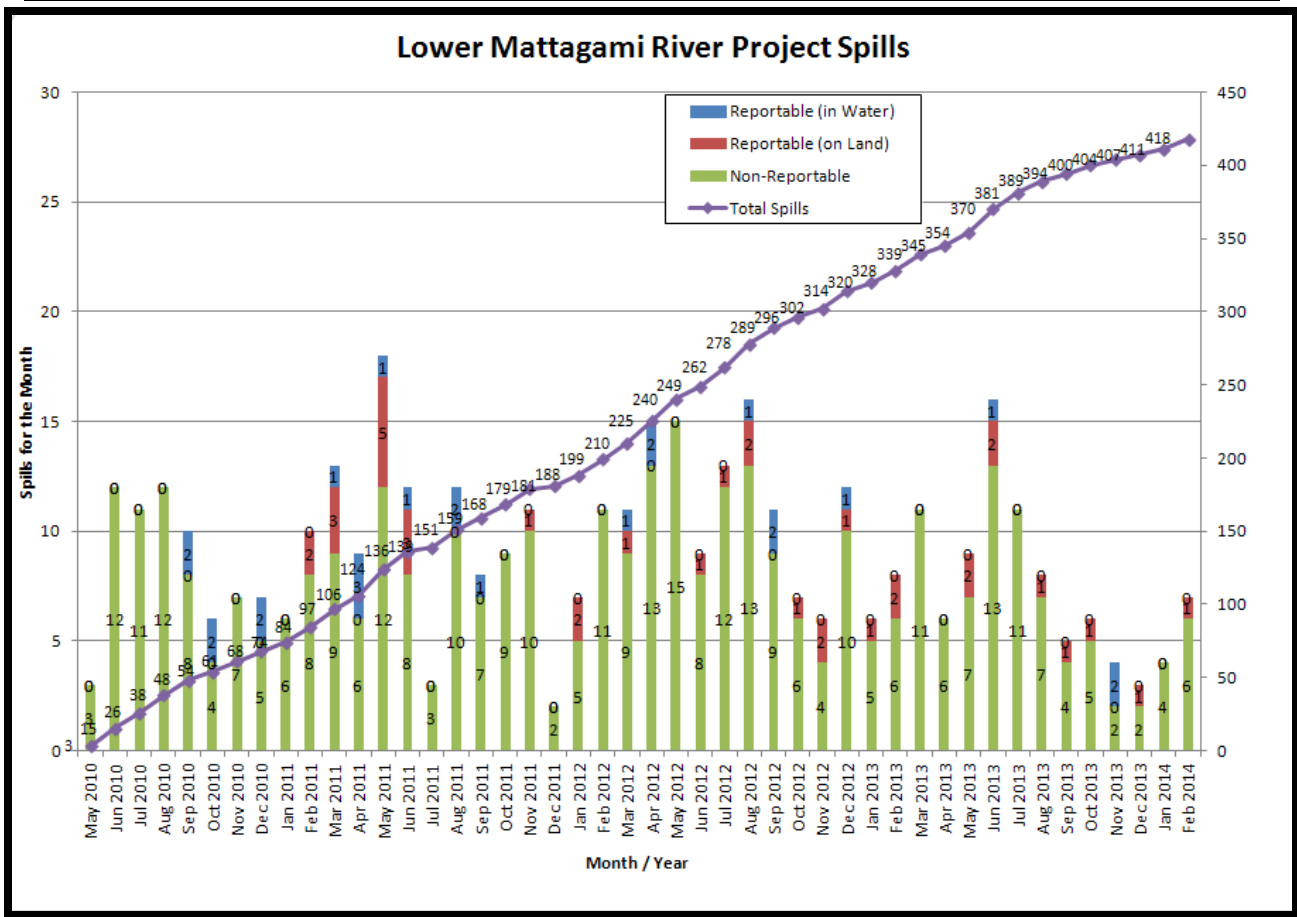
Figure 6: Lower Mattagami River Project spills

<b>SPILLS</b>			
<b>No. of Spills:</b>	7; Spill Reports 412-418 (see Figure 6 for LMRP spills breakdown).		
<b>Classification of Spills:</b>	<p><u>KAP Project Classification</u>                      Minor – 6 Moderate – 0 Major –1 To Water - 0</p> <p><u>MOE Classification</u>                      Non-reportable - 6                      Reportable to MOE</p> <ul style="list-style-type: none"> <li>- Class C – 1</li> <li>- Class B – 0</li> <li>- Class A – 0</li> </ul>		
Reportable Spills			
No.	Quantity /Product Spilled	Spill Site	Reason for being Reportable
1	Septic wastewater	Main Camp – Dorm 26	<p>Reportable on-land. During an inspection of the dorm it was determined that the main line leading from the building to the holding tank was leaking. An estimated volume is 1600 L based on the typical sewage design criteria of 200 L/person/day. Only 4 people were staying in the dorm over those previous two days. No solid material was spilled as the leak was not of sufficient size for large material to pass through. Pipe collects water from the laundry facilities, toilets, sinks and showers of the dorm. All of the water remained under the dorm and froze on top of the underlying pad.</p> <p>This connection may have cracked due to frost heaving the underlying gravel pad or frozen due to lack of use with the low number of people using the facilities causing ice to build-up inside of the elbow. The remaining dorms have a straight connection down to the pipes leading to the waste water treatment plant and are less susceptible to movement and freezing. The temporary dorms are in the process of being taken out of service so the holding tanks will no longer be used.</p>
