**Environmental Working Group**

**Monthly Report**

**October 2013**

# ENVIRONMENTAL WORKING GROUP

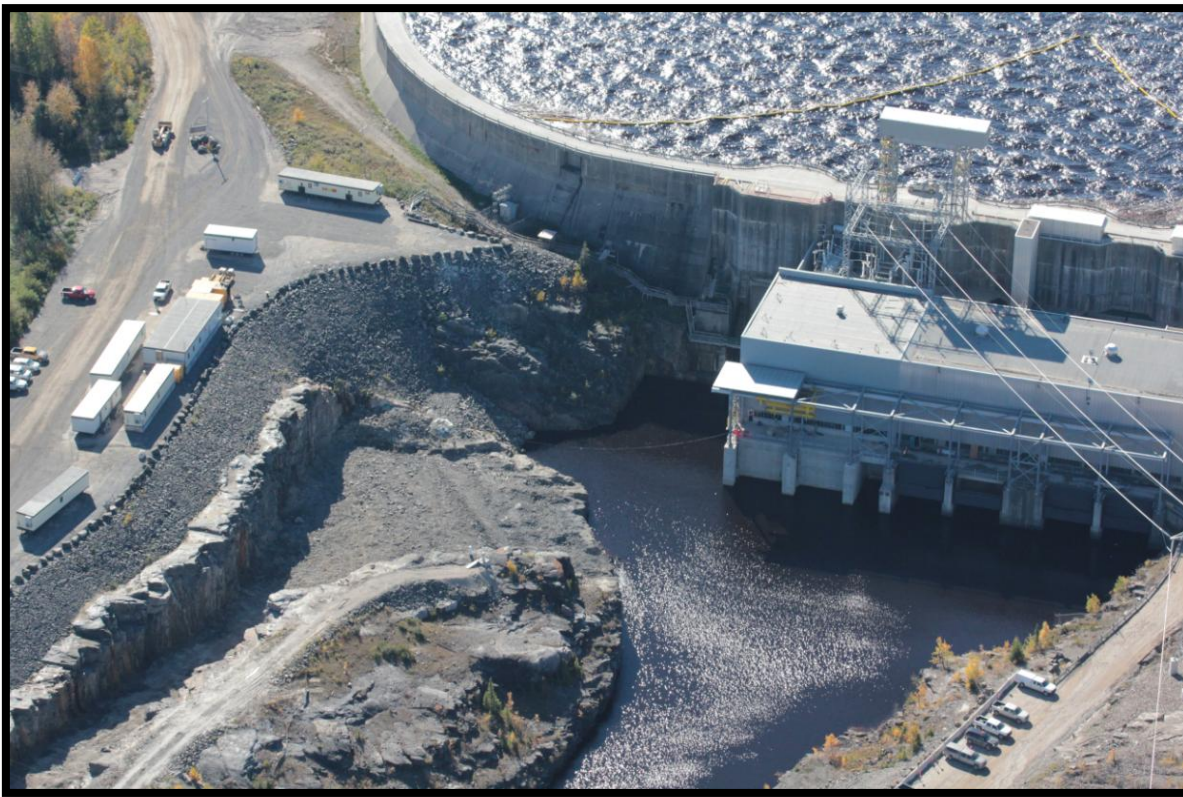
Figure 1: Little Long Overview.

- The focus of work in October was the completion of equipment installation; testing and commissioning; and Transfer of Control documentation.
- The root cause investigation identified a lack of sufficient clearance between the runner and the discharge ring as the root cause of the runner / discharge ring contact. KAP and Andritz identified further grinding of the discharge ring to increase clearances.

- Following the grinding, load rejection tests were performed at 25%, 50%, 75% and 100% of Unit power. More rubbing was identified on the discharge ring. Following further analysis, more grinding on the downstream side of the discharge ring was deemed necessary.

- Scratches were observed on the guide bearing pads. The pads were stoned to remove high spots. The turbine guide bearing oil pipes were flushed to ensure no debris remained in the guide bearing oil system.

- The KAP grouting crew continued to inject epoxy grout into the cracks in the concrete as a remedial measure for the leakage identified last month.
- A number of components and systems were walked down.

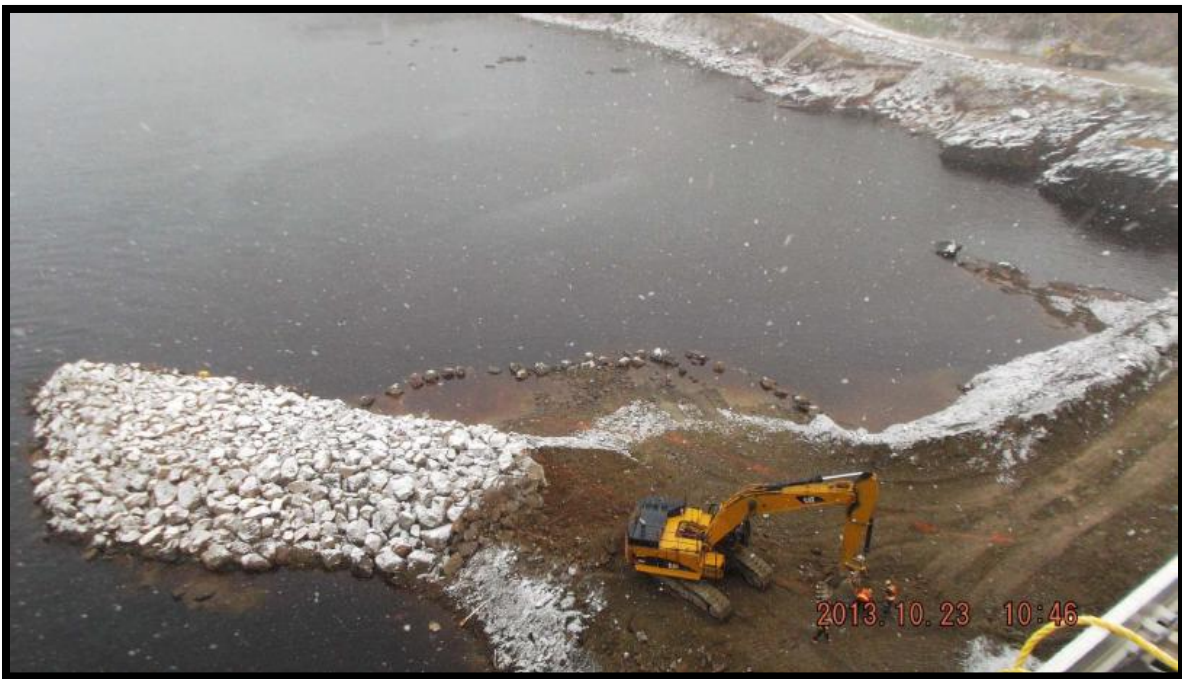
Figure 2: Harmon Marine Pad removal

- Equipment was demobilized from the marine pad, and excavation of material is nearing completion at month-end (Figure 2). The spillway bridge is forecast to be removed by mid-November.

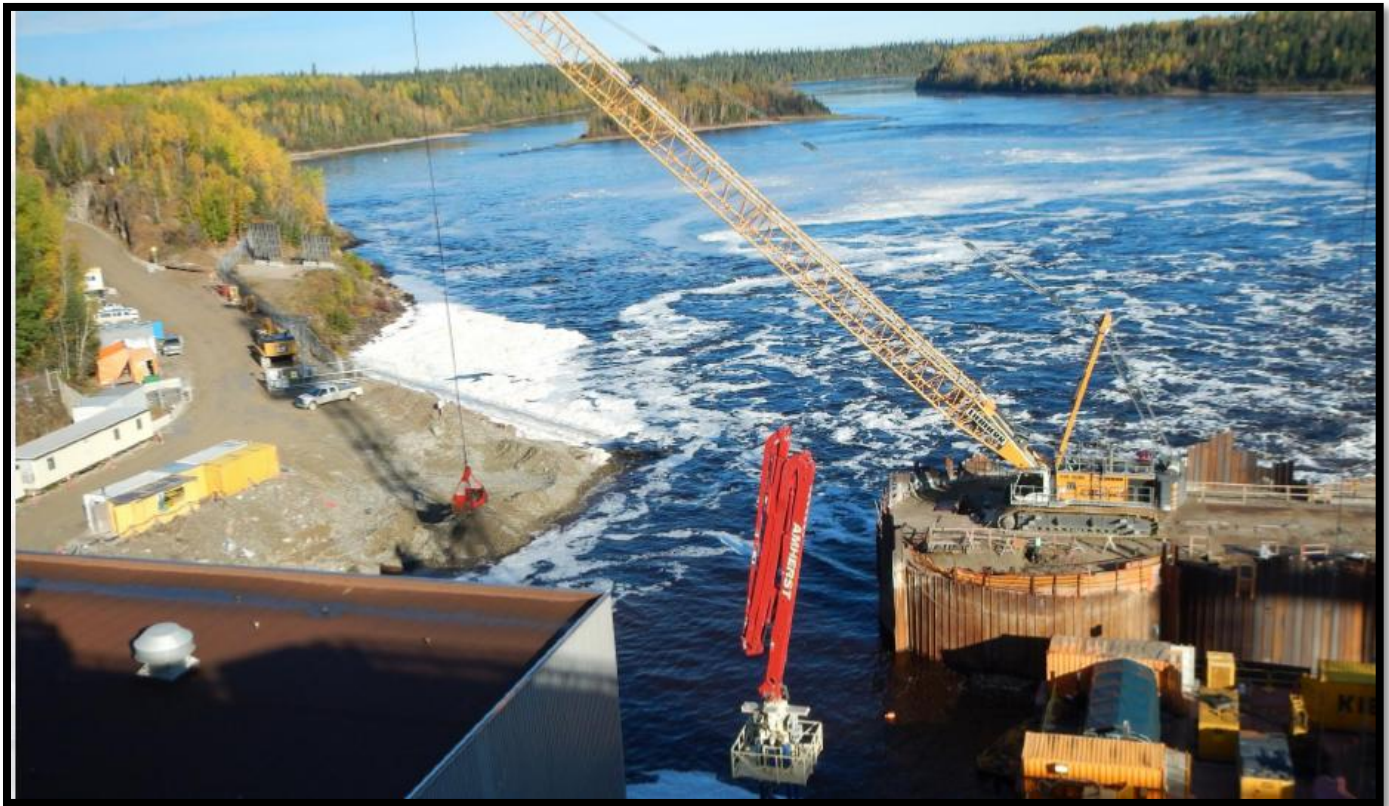
Figure 3: Kipling – Earth berm removal

- 587 m<sup>3</sup> of concrete was poured this month, bringing the total poured to date to 10,954 m<sup>3</sup> of 11,885 m<sup>3</sup> total.
- The earth berm removal (Figure 4) was completed by October 21 and Units 1 and 2 were turned over to OPG. NEPG is performing some maintenance and the Units are expected to resume production in early November.
- Removal of fill from Cell 2 of the cellular cofferdam has started.
- The switchyard was backfilled with clear stone.
- Welding of the intake gate overlays was completed on the original sill beam, lintel and east and west sealing surfaces.
- Machining of the upper flange of the stay ring was completed.
- The discharge ring was installed in the Unit using the tower crane.

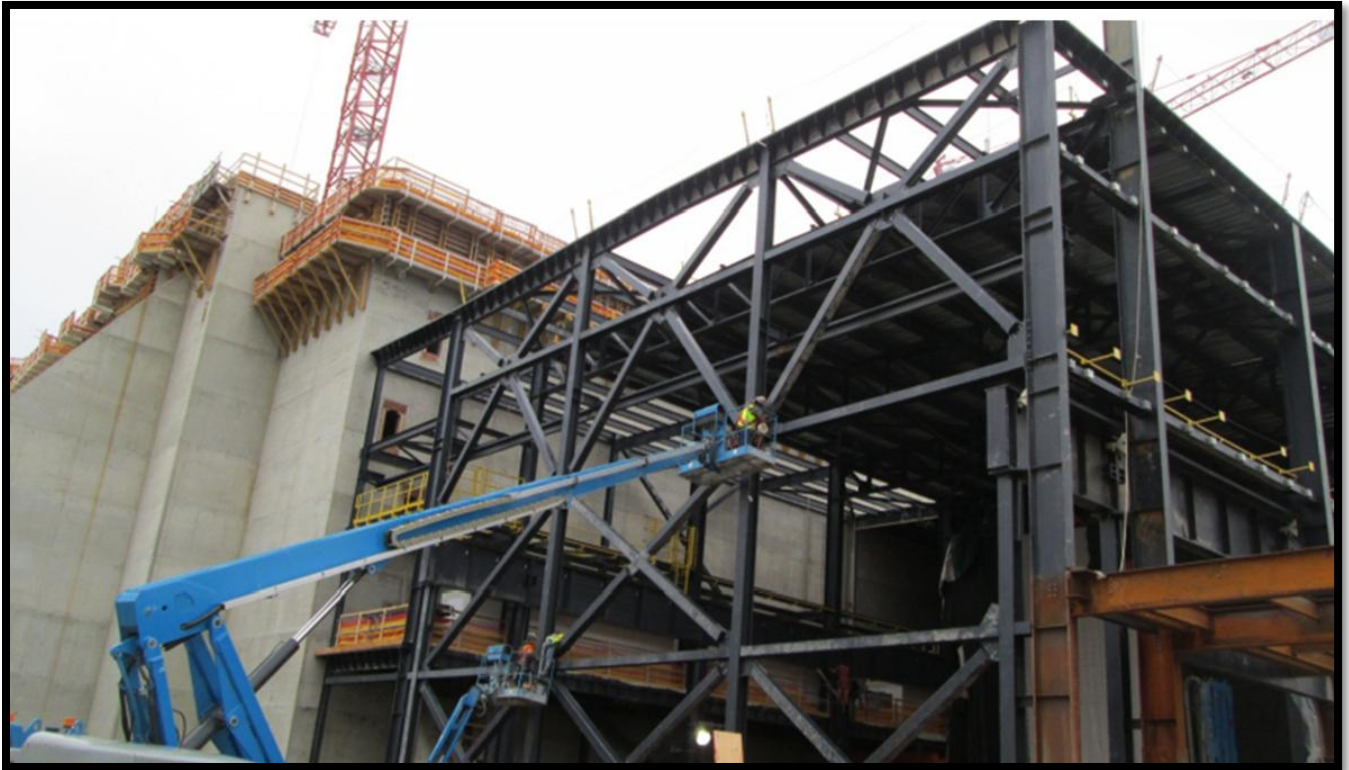
Figure 4: Smoky Falls – Superstructure erection

- Supermétal completed erecting the Unit 3 superstructure and installed the crane girders in Unit 3 (Figure 4). They also completed installing Q-decking on structural steel for the Unit 3 roof, transformer and tailrace decks at Unit 3, in various areas in the mezzanines and the East Service Bay.

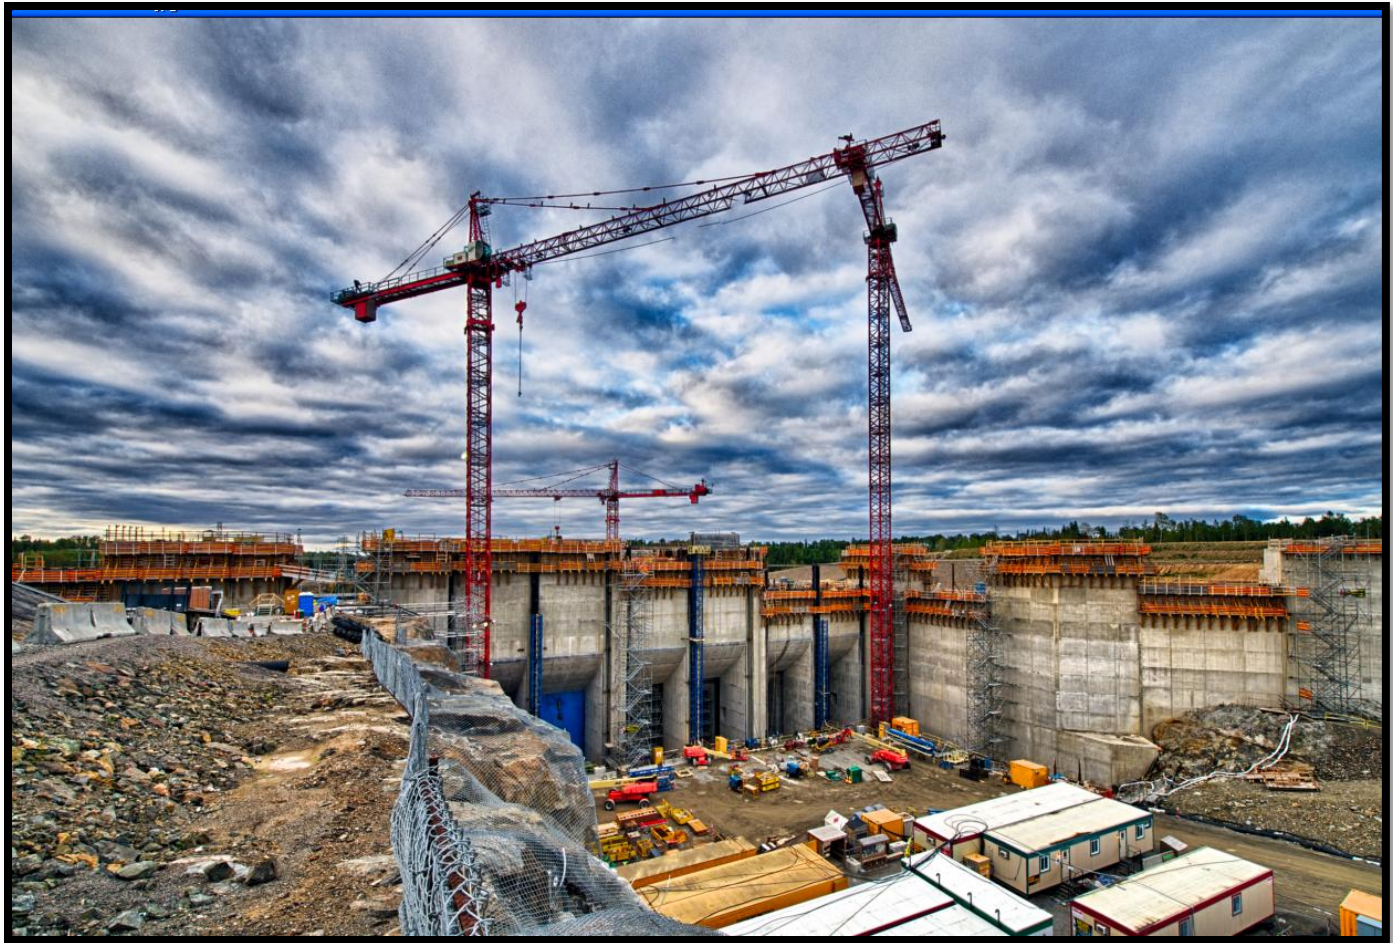
Figure 5: Smoky Falls Intakes

- Gate guide installation is advancing on the intakes on all 3 units (Figure 5). Concrete has been poured for Unit 1 bulkhead and intake lower gate guides. Canmec is preparing to pour concrete for the Unit 2 gate guides.

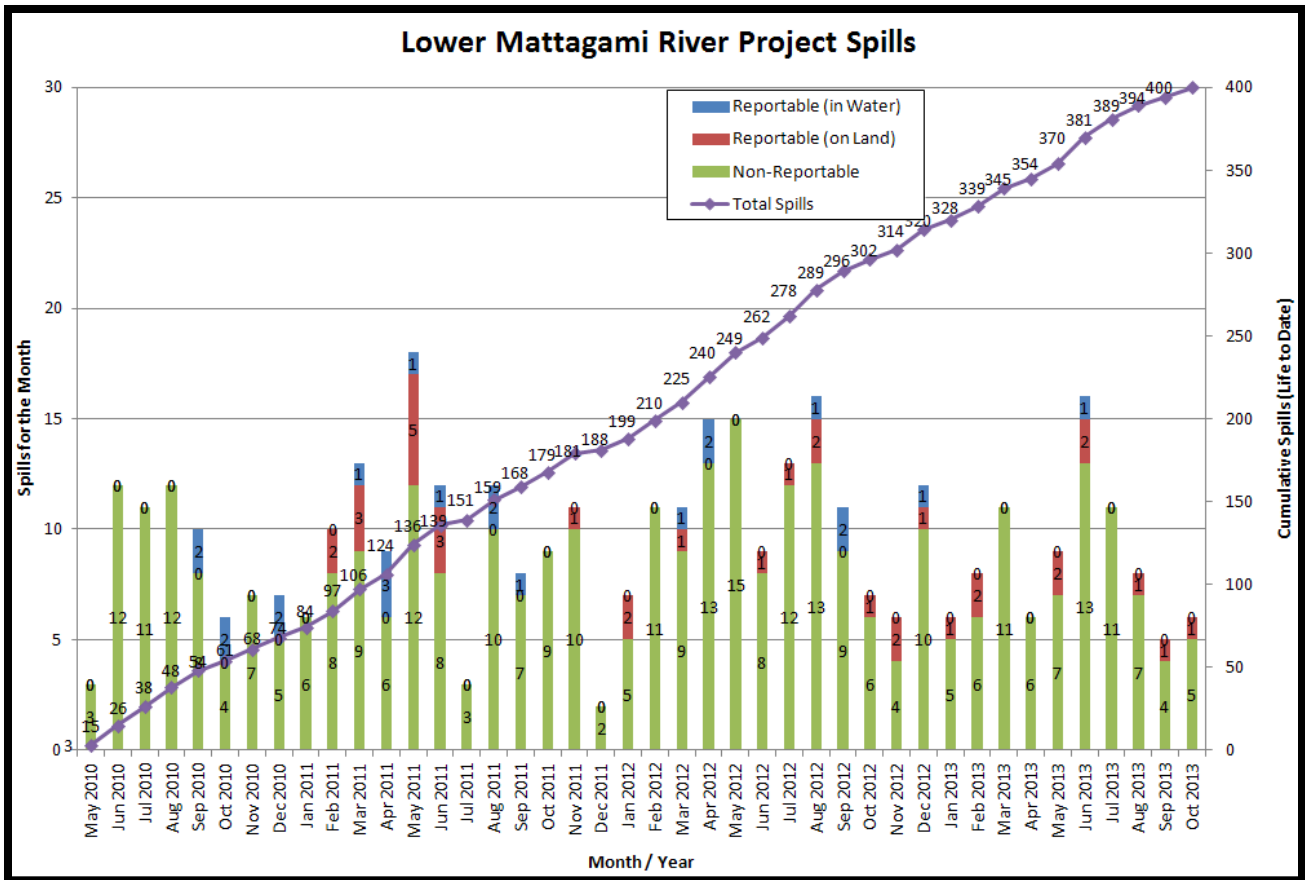
Figure 6: Lower Mattagami River Project spills

<b>SPILLS</b>			
<b>No. of Spills:</b>	6; Spill Reports 395-400 (see Figure 6 for LMRP spills breakdown).		
<b>Classification of Spills:</b>	<p><u>KAP Project Classification</u>                      Minor – 5 Moderate – 0 Major –1 To Water - 0</p> <p><u>MOE Classification</u>                      Non-reportable - 5                      Reportable to MOE</p> <ul style="list-style-type: none"> <li>- Class C – 1</li> <li>- Class B – 0</li> <li>- Class A – 0</li> </ul>		
Reportable Spills			
No.	Quantity /Product Spilled	Spill Site	Reason for being Reportable
1	800 L/ 50% Citric Acid	Smoky Falls – Site Services Dome	Reportable spill on-land. The cause of the spill was a combination of factors. The primary valve on the tote was damaged and this allowed acid to corrode the metal fitting attached. The tote was located on secondary containment, but the containment was determined to have a crack. This allowed acid to drain out of the containment onto the gravel pad inside the dome and out to the parking lot. All remaining totes were inspected to ensure valves were in good condition and any metal fittings were removed and replaced with a plastic cap to provide secondary protection.

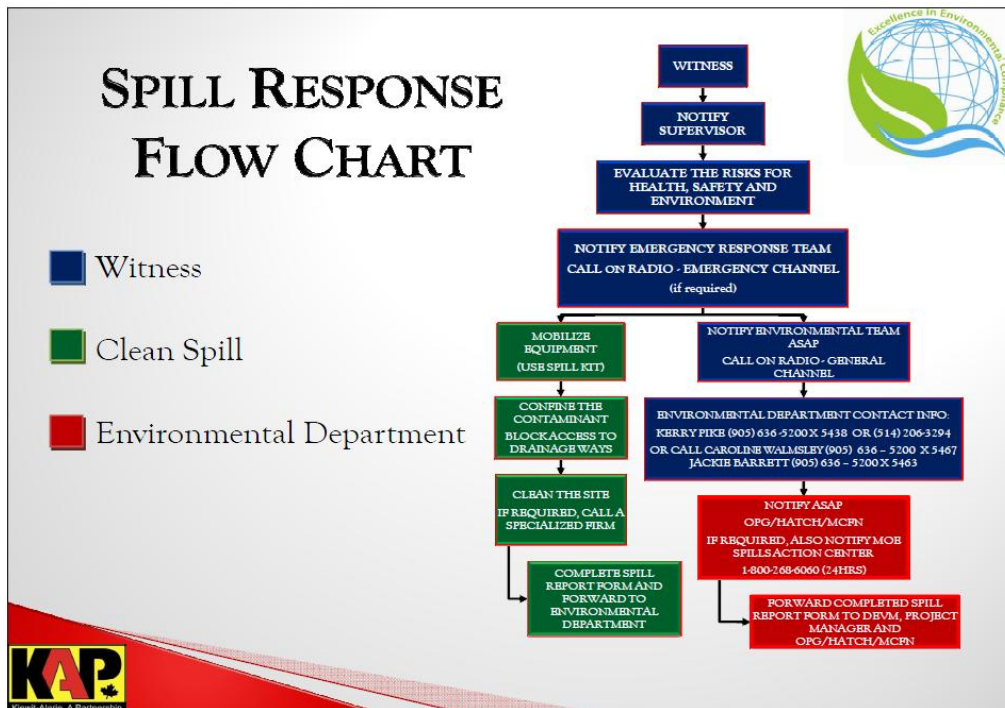
Figure 7: KAP Spills Response Flowchart

When **any spill** occurs on site, KAPs spill response process is to be followed (Figure 7). This includes notification of the Supervisor and KAPs Environmental Department, and an assessment of the severity of the spill. Regardless of the quantity, clean-up measures are implemented for **every spill** using spill kits that are available throughout the site (materials used for clean-up and any contaminated soil are removed from the site). A spill report is then prepared for **each spill that occurs** which outlines the location, type, severity and quantity of the spill, in addition to details on how the spill occurred, how it was cleaned up and measures implemented on how the spill could be avoided for the future. This report is sent out to several OPG and Hatch representatives as well as all EWG members.

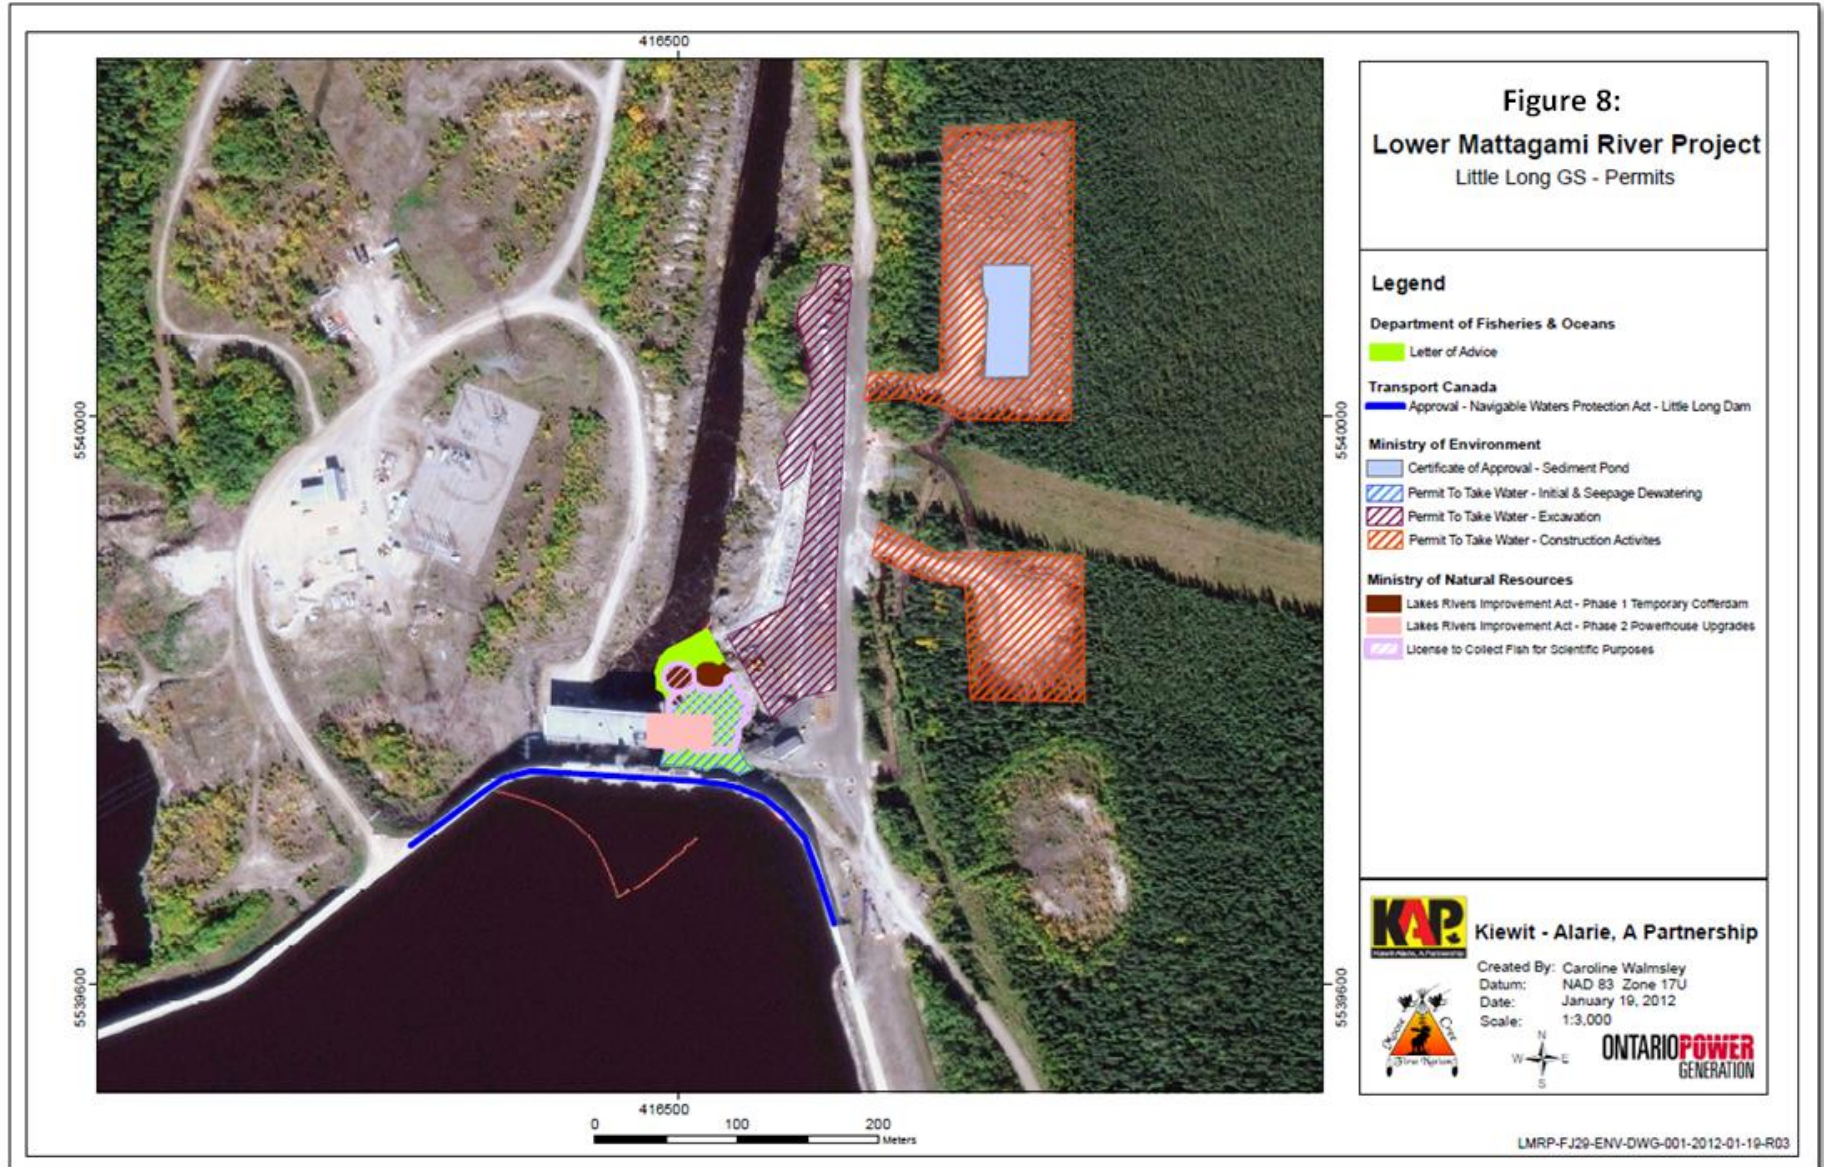
<b>REQUESTS FOR INFORMATION (RFIs)</b>			
No. Reviewed:	0	List:	n/a
No. Sent to KAP:	0	List:	n/a
See figures 8 to 13 below for site location of the permits that have been or are pending approval.
