Proposed Stinson Generating Station Life Extension Project

**Terrestrial Environment
Technical Support Document (Final Draft)**

January 2025

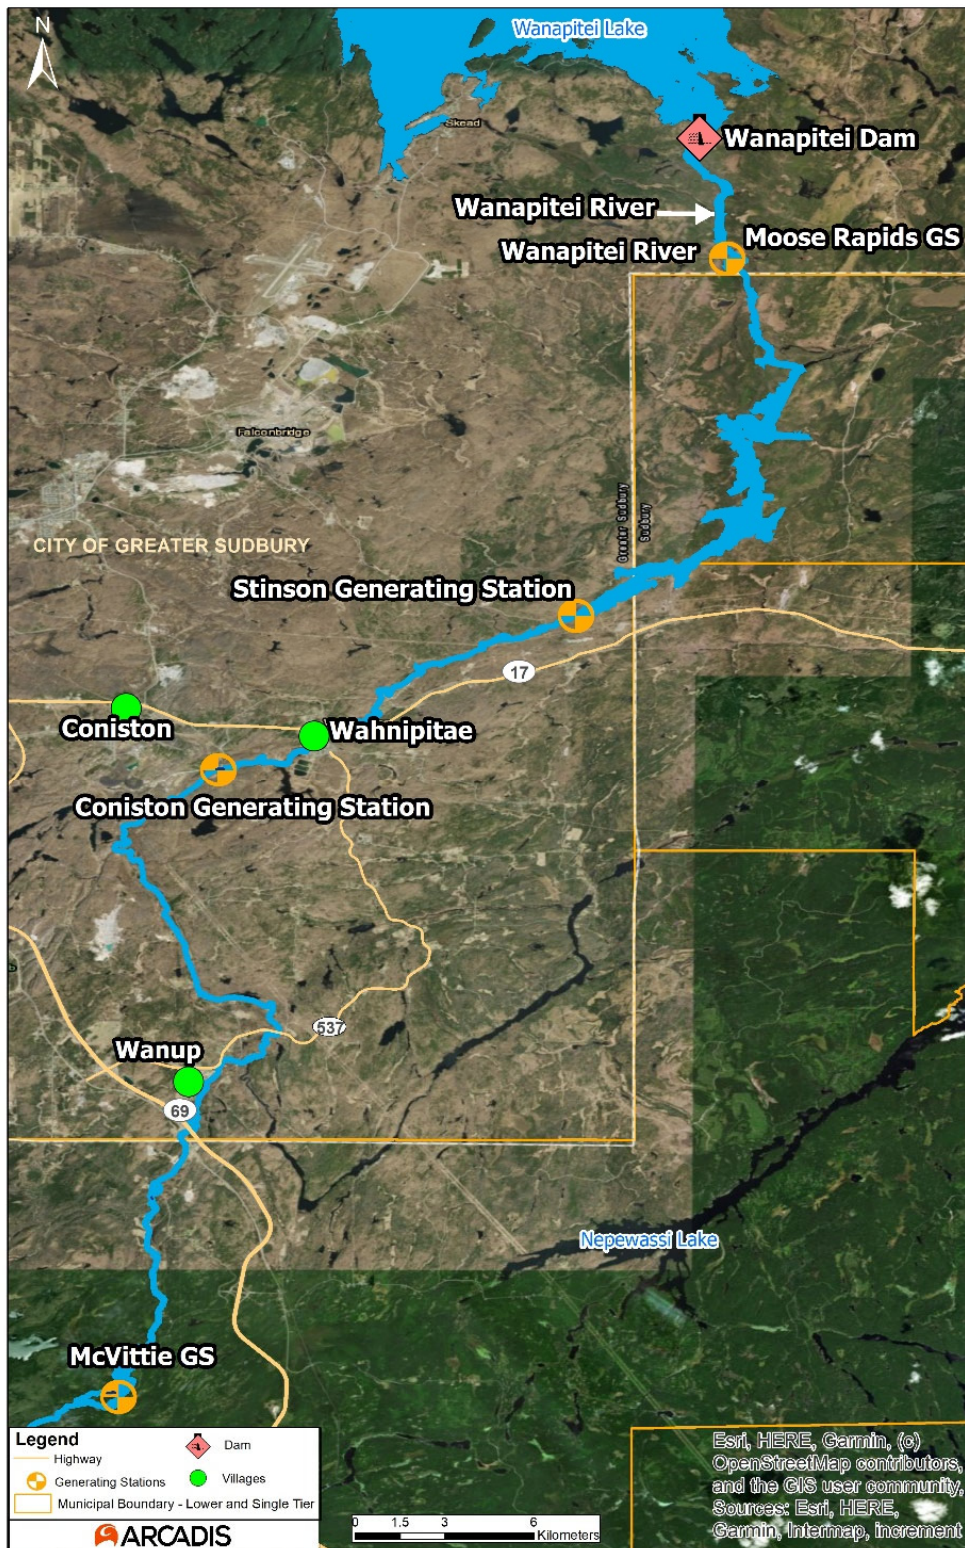
Figure 2-1 Location of the Stinson GS

Stinson GS is located within the boundary of the City of Greater Sudbury. The GS is located on the Wanapitei River approximately 25 kilometres east of the city centre of Sudbury and approximately 20 km downstream of the Wanapitei Lake control dam. The Wanapitei River is a tributary of the French River and has its headwaters north of Stinson with the first large waterbody being Wanapitei Lake. The Stinson GS is upstream of OPG's Coniston GS and downstream of Moose Rapids GS (which is privately owned) (see Figure 2-1).

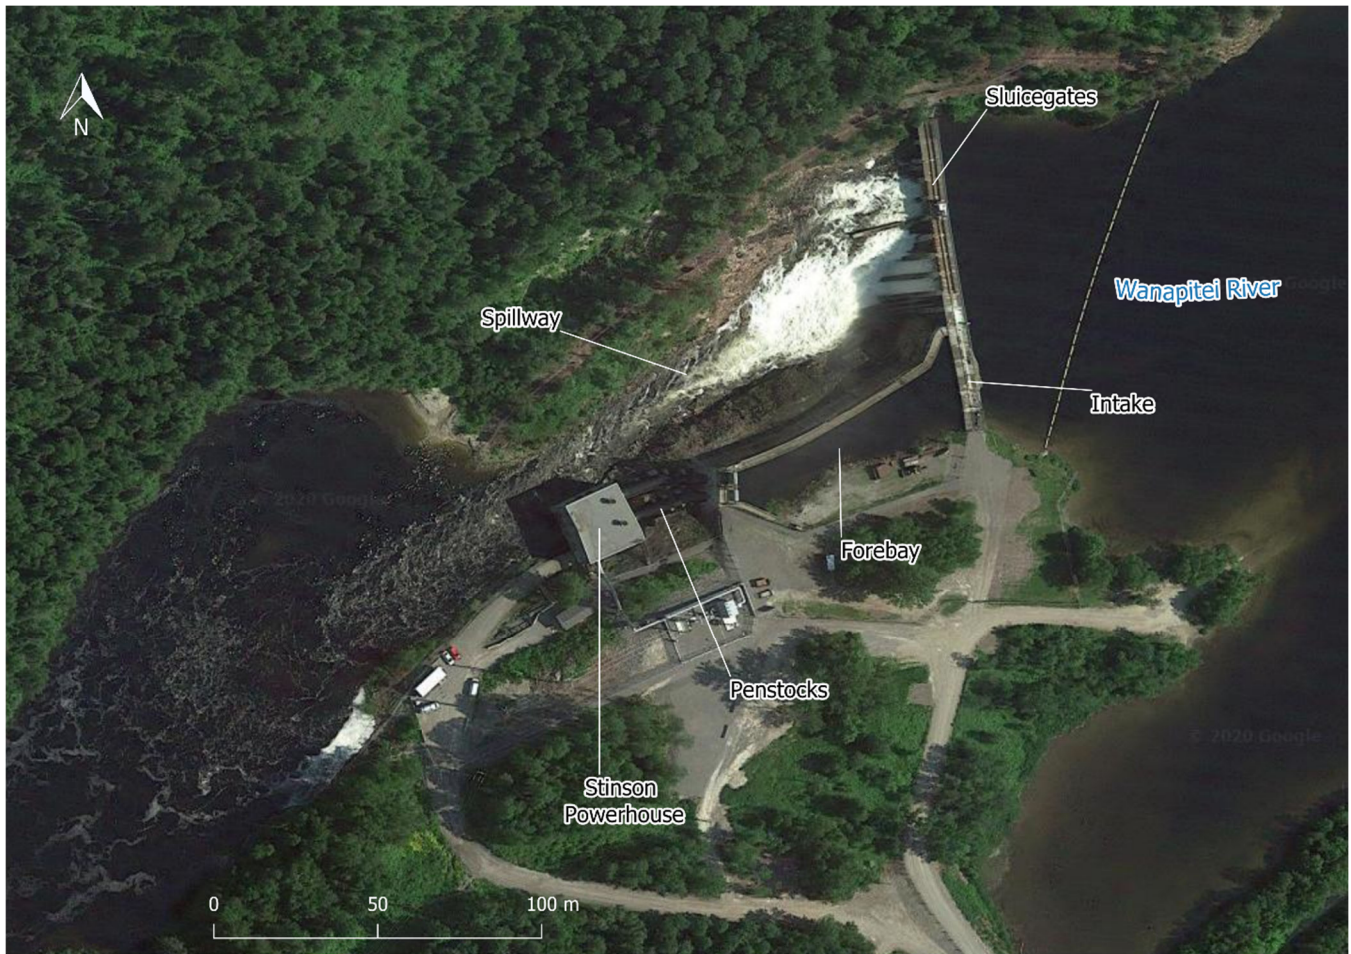
Figure 2-2 Site Overview

Figure 2-2 below is an aerial photograph of the site with key features labelled.

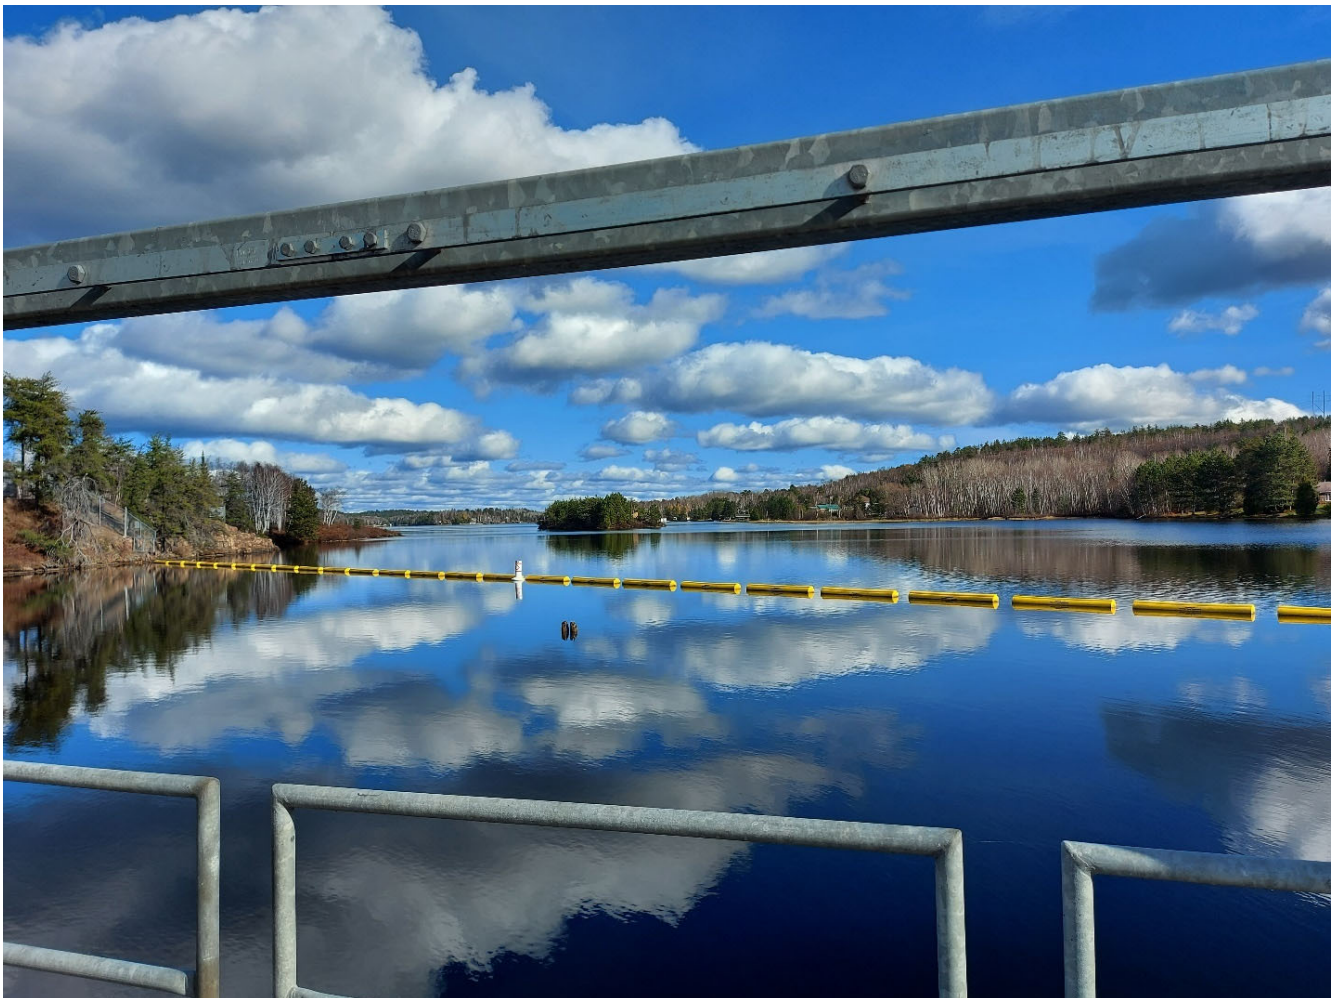
Figure 2-3 Stinson Reservoir (looking upstream from the main dam)

Figure 2-3 is a photograph looking upstream to the reservoir from the Stinson Dam.

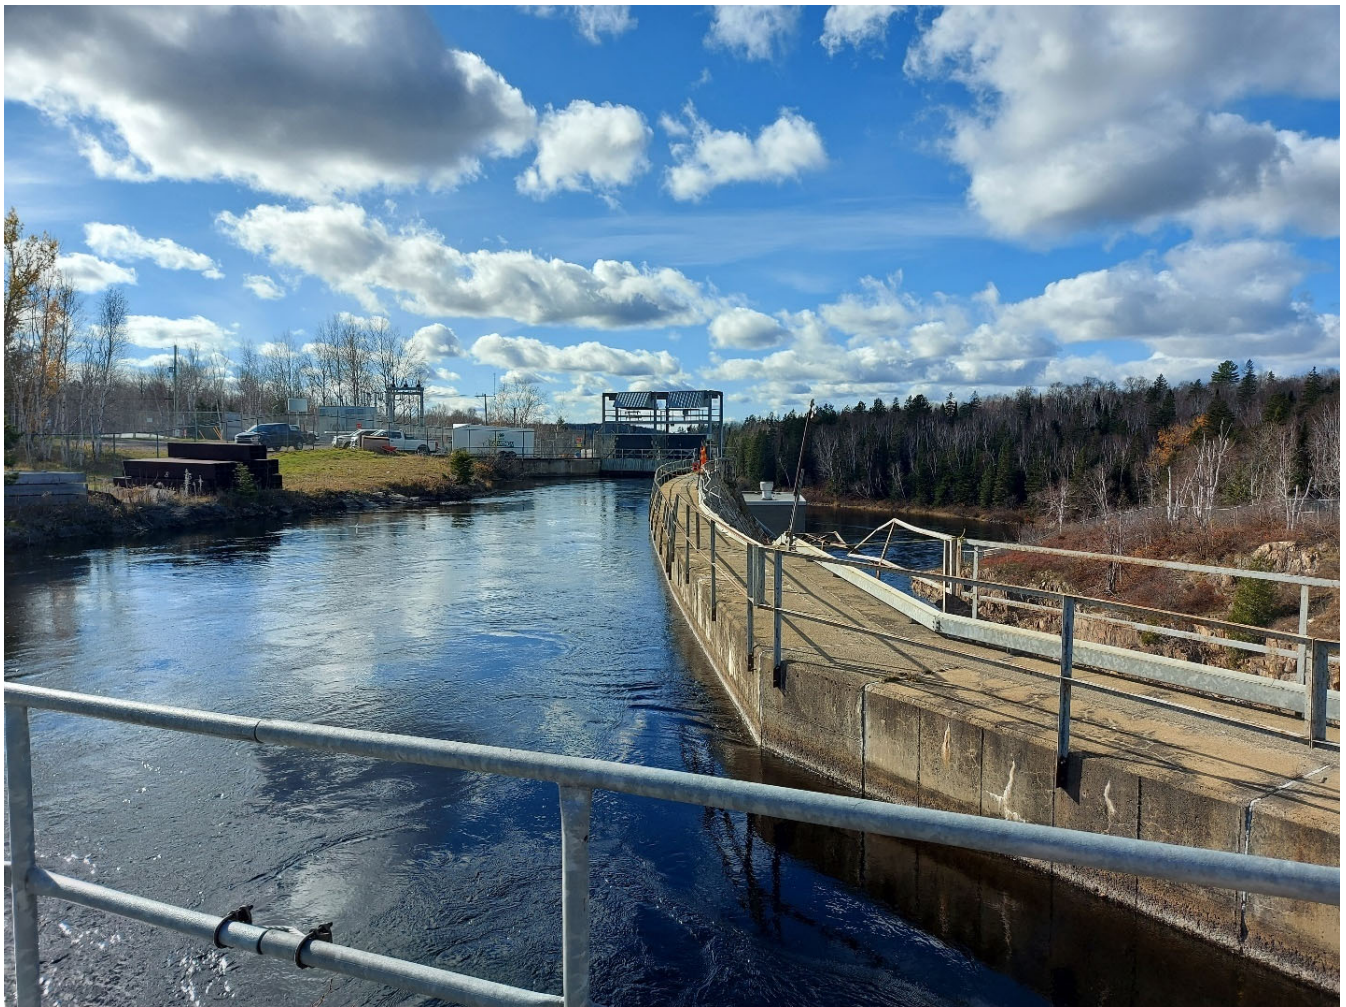
Figure 2-4 Stinson Intake Canal

Figure 2-4 shows the forebay to the Stinson powerhouse.

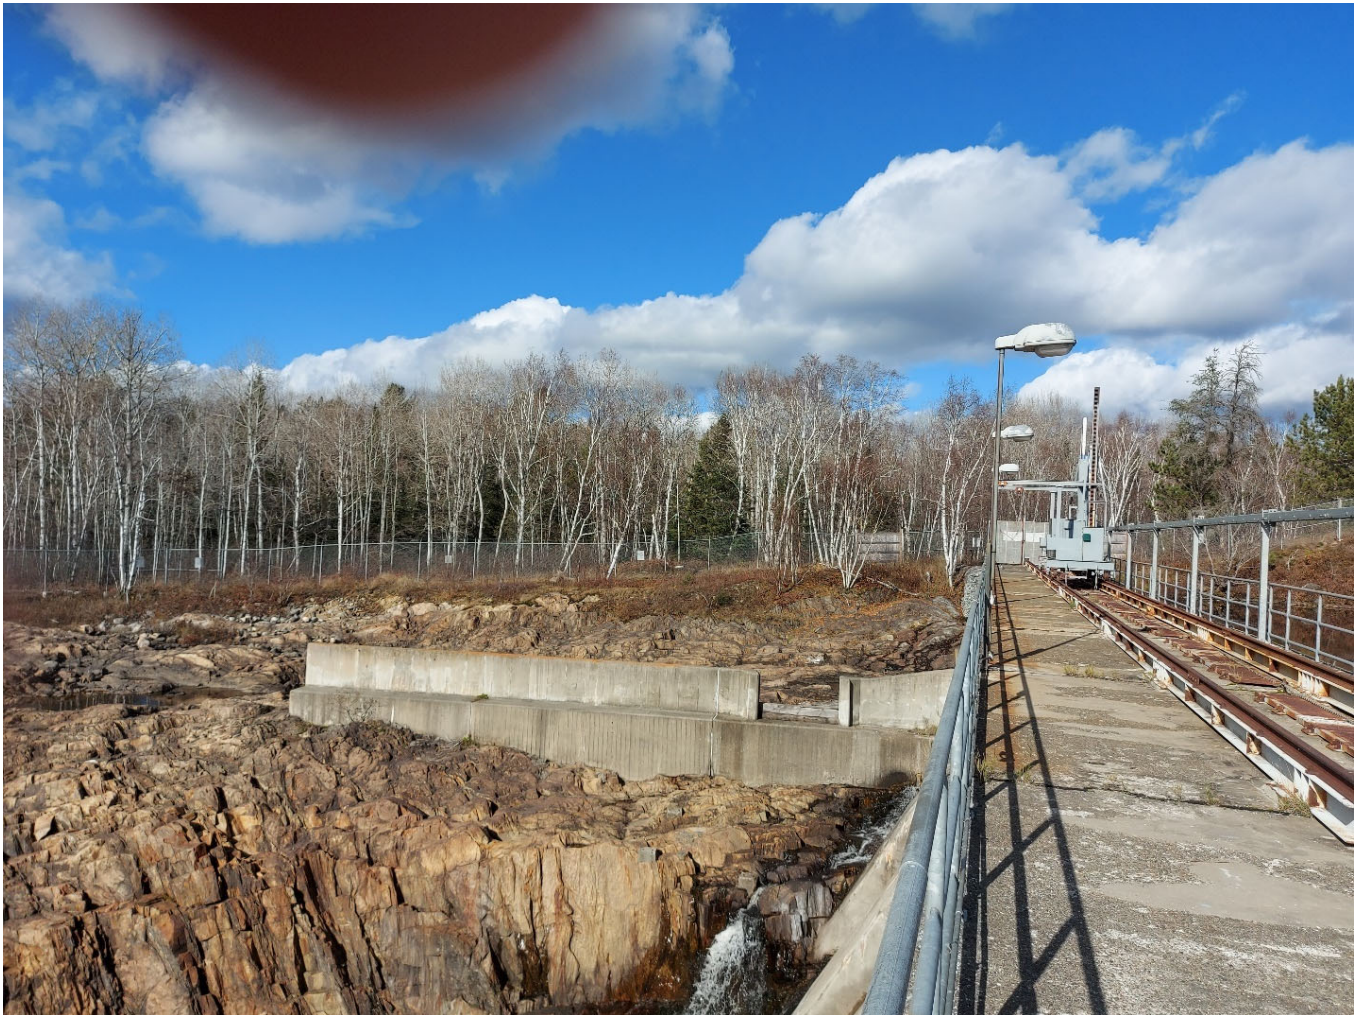
Figure 2-5 Stinson Main Dam

Figure 2-5 shows the Stinson Main Dam.

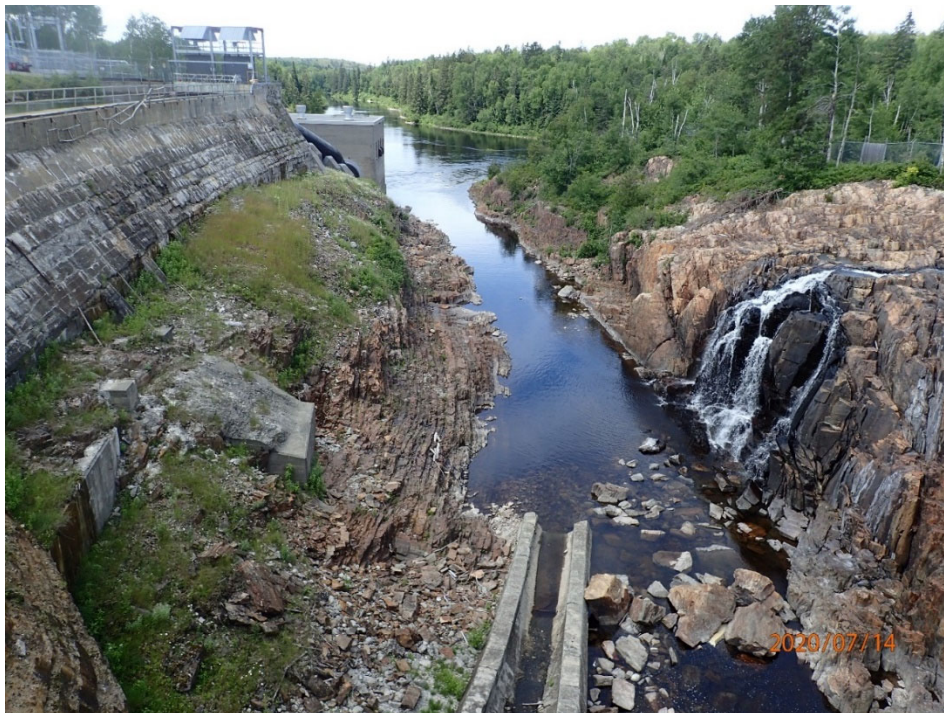
Figure 2-6 Stinson Spillway: Leakage Flow Only

Figure 2-6 and Figure 2-7 show the Spillway at no flow and partial flow.

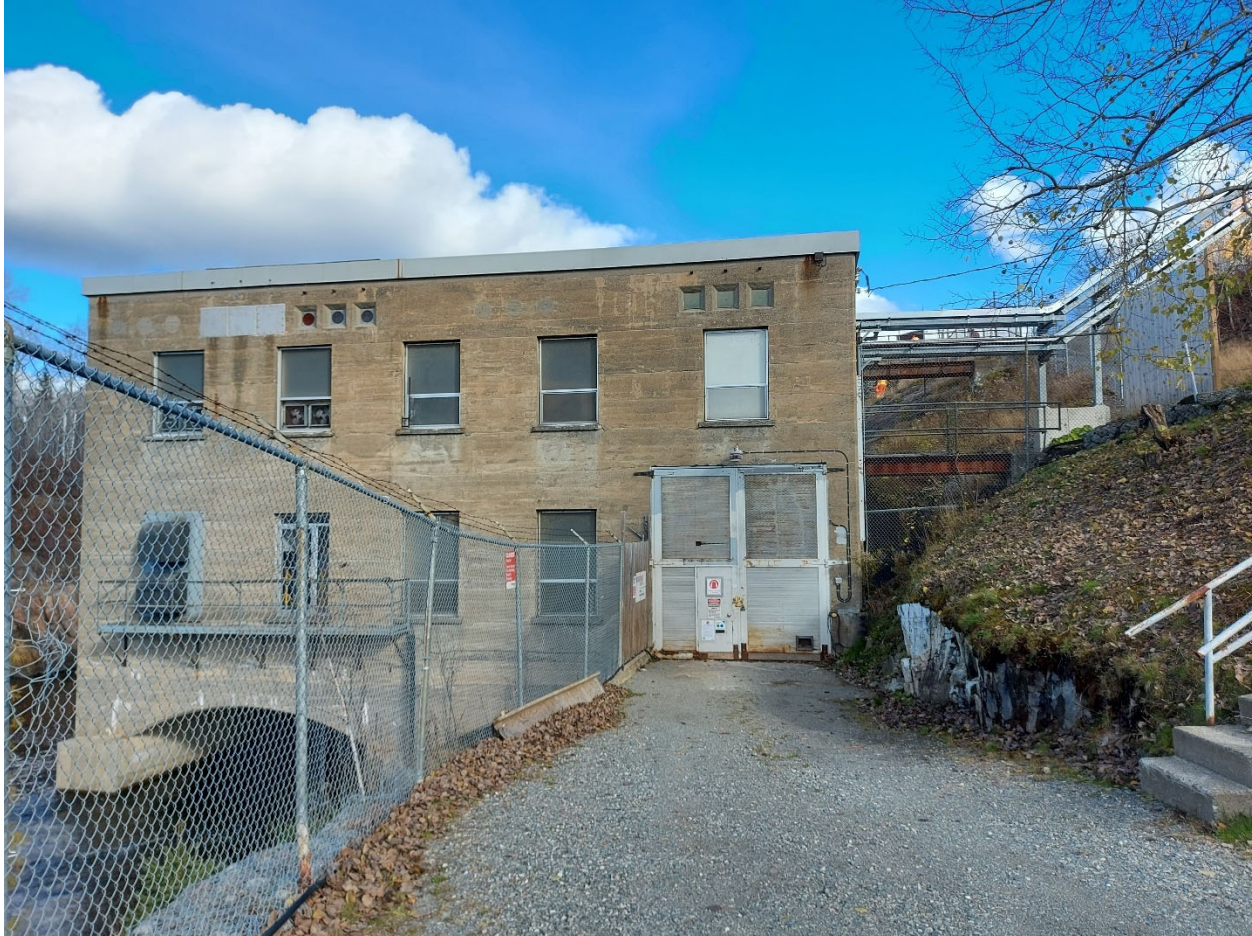
Figure 2-8 Stinson Powerhouse

Figure 2-8 shows the powerhouse and vehicular access.

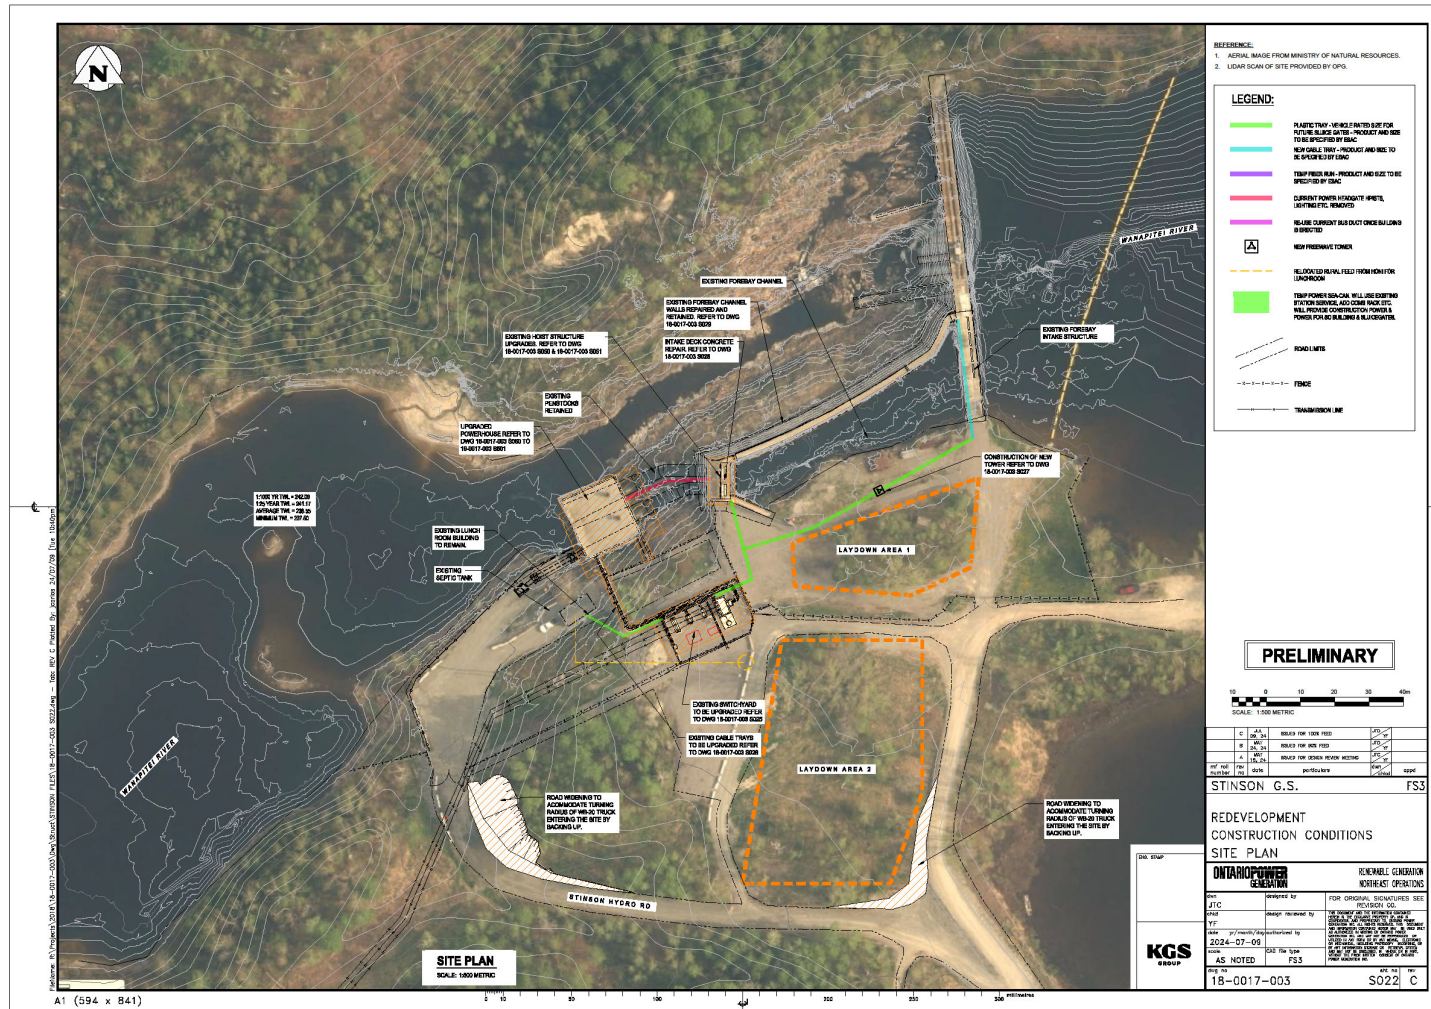
Figure 2-10 Proposed General Arrangement Site Plan for Construction for the Stinson GS

Figure 2-10 shows the site plan during the construction period. In order to providing working space for the construction two laydown areas are proposed south of the intake canal and shown on the Figure. The repair work for man-made intake canal channel walls and intake deck are shown. Figure 2-10 and Figure 2-11 shows the proposed road modifications. These proposed road modifications will allow for improved accessibility for trucks. All the proposed road modifications occur on OPG property.

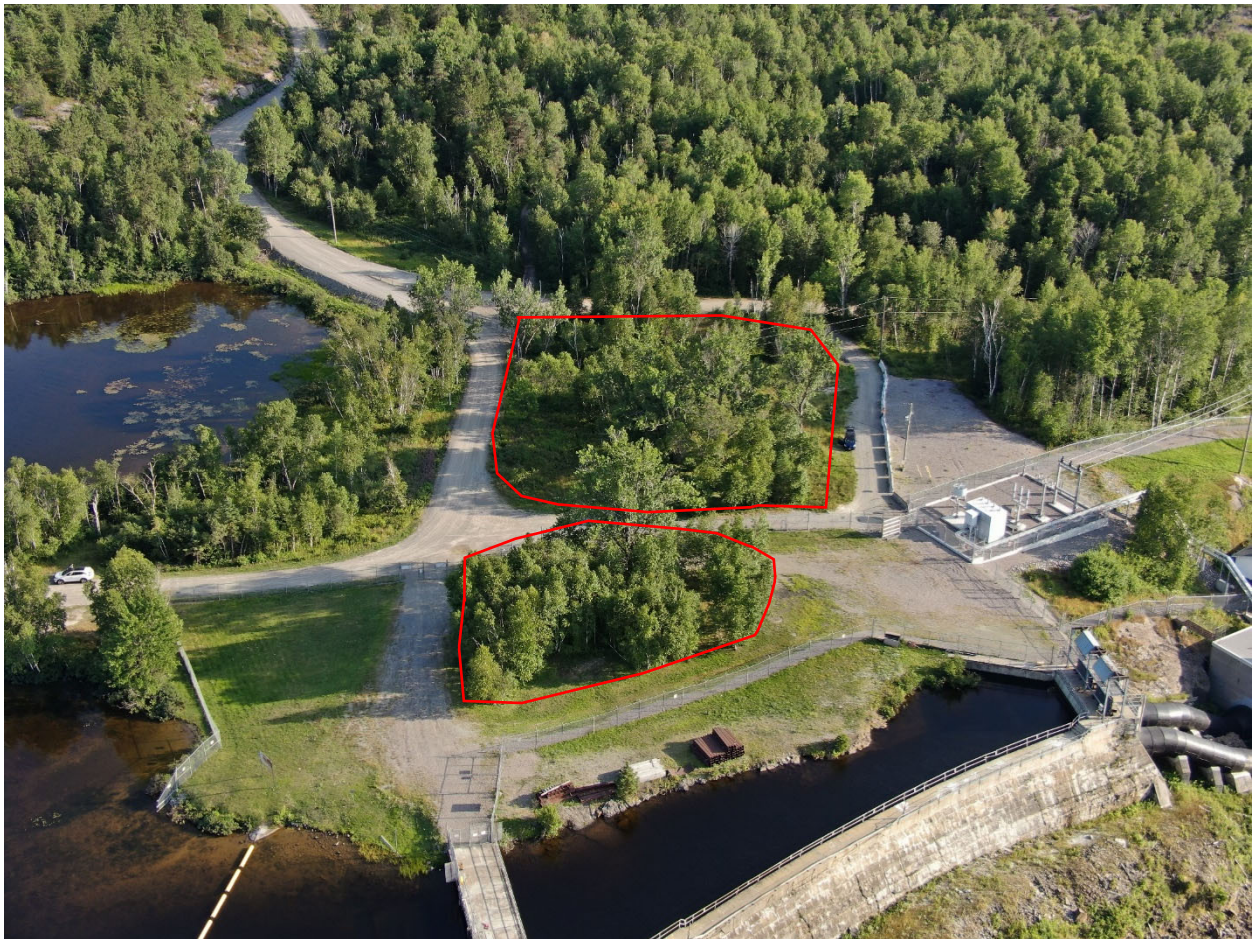
Figure 3-3 Oblique View of Treed Areas Likely to Be Removed for Laydown That Are Within Category 2 Habitat for Eastern Whip-Poor-Will (July 31, 2022)

Vocalizations from a male breeding Whip-poor-will were documented during both on-site surveys and with a remotely deployed acoustic detector. The acoustic detector documented the male's vocalizations in close proximity on almost all of the days it was deployed. The male's territory is estimated to encompass the Stinson GS on both sides of the river. The Wanapitei River in this area has a combination of open rock barren, interspersed with forest, and as such makes the area ideal habitat for the species. Preliminary assessment indicates that much of the proposed laydown area for the project (see Figure 3-3 and Figure 3-4) would be defined as Category 2 Whip-poor-will habitat following the general habitat description for the species (MECP 2021). There may not be practical alternatives to these laydown areas for the project given slopes and access, and it is therefore likely that these areas will be highly disturbed for laydown equipment and activity during the time when the GS is being refurbished. Additional male Whip-poor-wills were detected vocalizing outside of the study area as well.

As indicated in Section 3.3.4, vocalizations from a male breeding Whip-poor-will were documented during both on-site surveys and with a remotely deployed acoustic detector. The male's territory is estimated to encompass the Stinson GS on both sides of the river. The Wanapitei River in this area has a combination of open rock barren, interspersed with forest, and as such, makes the area ideal habitat for the species. Preliminary assessment indicates that much of the proposed laydown area for the project (see Figure 3-3 and Figure 3-4) would be defined as Category 2 Whip-poor-will habitat following the general habitat description for the species (MECP 2021). There may not be practical alternatives to these laydown areas for the project given slopes and access, and it is therefore likely these areas will be highly disturbed for laydown equipment and activity during the time when the generating station is being refurbished.
